MUIZENBERG PEDESTRIAN TOURISM ROUTES

MUIZENBERG PEDESTRIAN  
TOURISM ROUTES  
November 2012

EARTHWORKS LANDSCAPE ARCHITECTS

ROUTE A\_HISTORICAL BUILDINGS AND BATTLE SITE ALONG BEACH ROAD

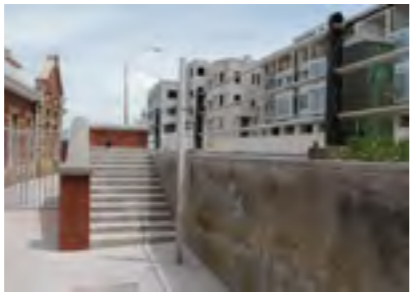
1. The station precinct was recently upgraded. The entrance is uncluttered. The coping on the walls have been recently repaired.

There is poor provision for wheelchair access, low walls cross the pathway at the entrance.

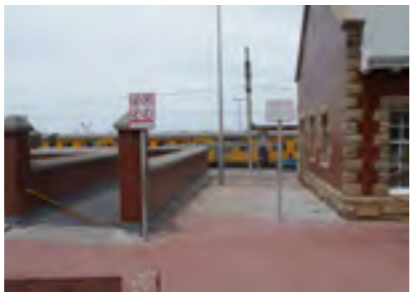
2. There are multiple signboards in close proximity that could form part of one signage board. Some signage dealing with traditional weapons is inappropriate in this precinct

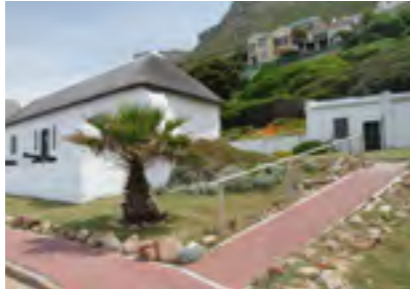
3. Paving along the sidewalk at Het Posthuis is in good condition, red brick with cobble edging is used to indicate historical significance. Historical stone kerbing has been retained along the sidewalk.

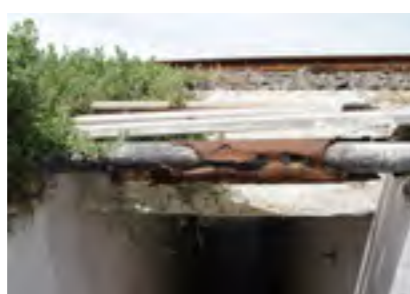
3. Asbestos piping and rusted piping exposed above subway entrance

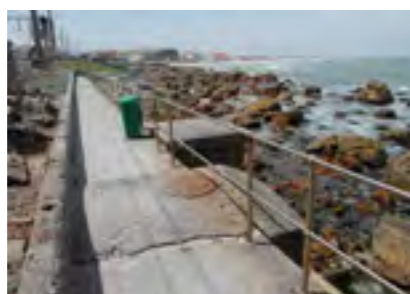
8. Green council bins are placed too frequently along the walkway creating a cluttered effect, there are far too many along this stretch

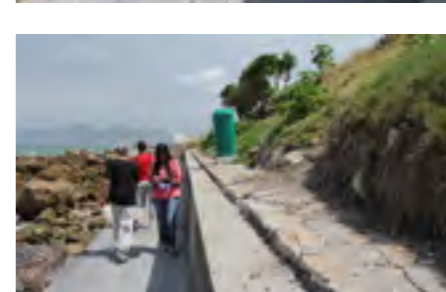
16. Broken benches along the walkway need to be repaired.

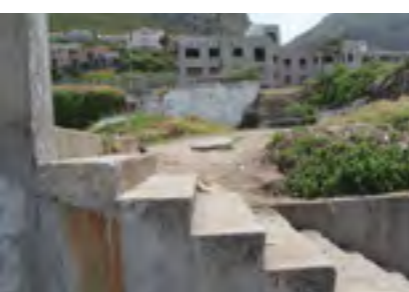
10. There is no signage to indicate access point to the road. These pathways are not clearly demarcated

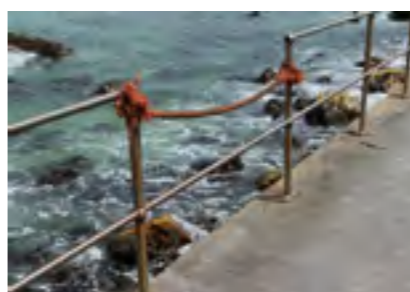
11. Balustrading has missing railings

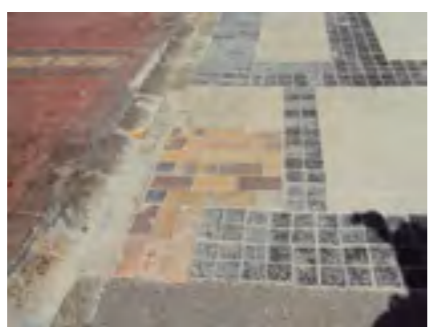
- 16. Repairs to the sidewalk are made with different paving materials to the original.

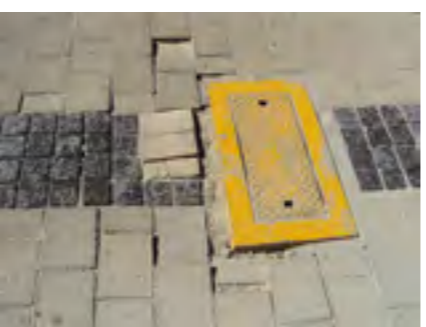
- 15. Degraded exposed aggregate and cobble paving

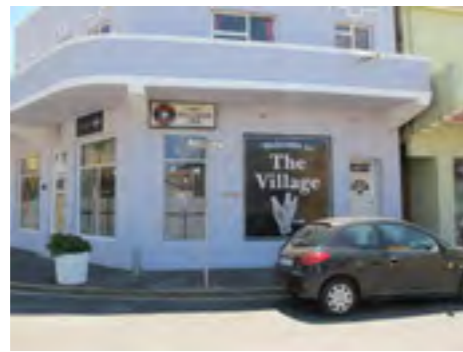
6. Village signage is not reflective of the character of the old village

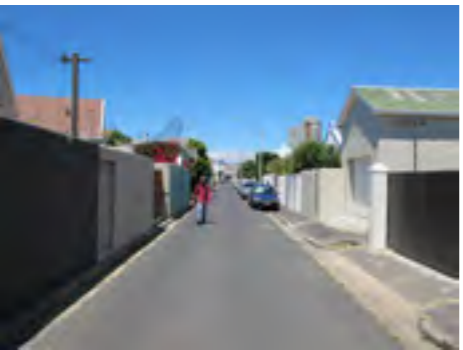
11. Sidewalks are very narrow and dominated by parked cars. Kerbs are not lowered to allow for wheelchair access. Historical kerb has been retained throughout the old village

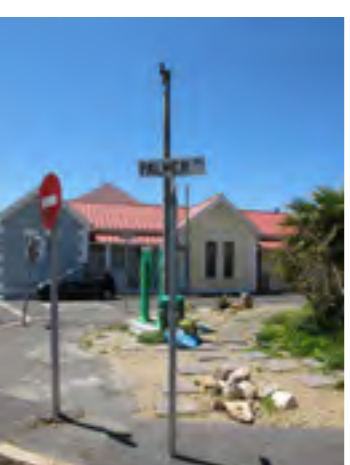
12. Asphalt is broken and patchy and in need of repair. Sign posts are placed in the middle of the sidewalks limiting universal access

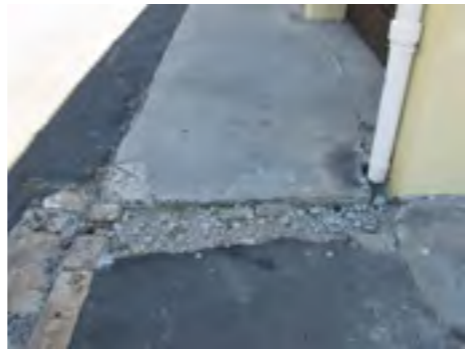
16. Broken asphalt to be repaired

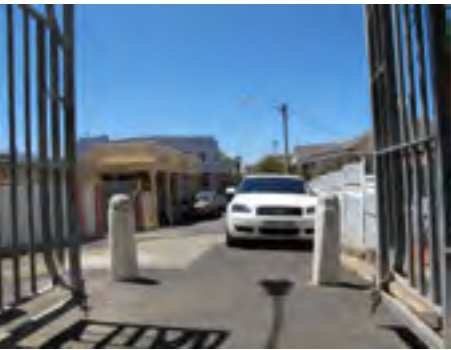
28. Asphalt is patchy and broken at village side of the subway

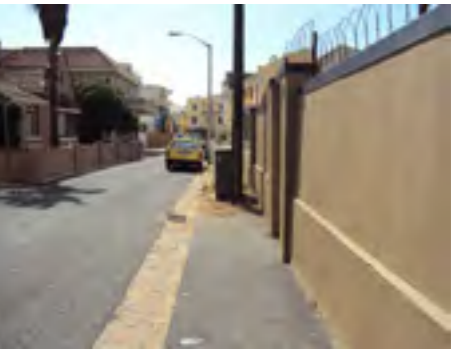
30. Church Street - there is a narrow sidewalk on one side of the road. Light posts and bins block the sidewalk.

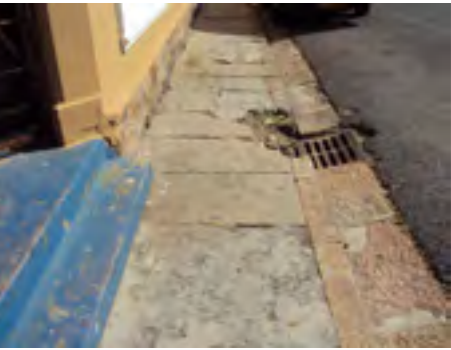
31. Hanson Street - the concrete sidewalks are degraded and need to be repaired.

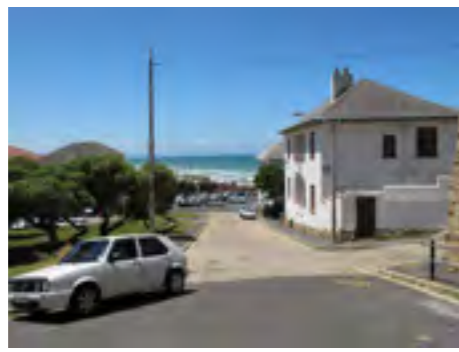
9. Historic stone paving should be retained and is in need of repair in some areas.

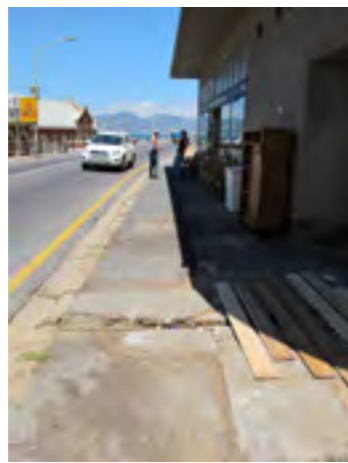
11. Drainage channel in asphalt sidewalk is in need of repair. Water is flooding the pedestrian route. Surrounding asphalt is patchy and in need of repair.

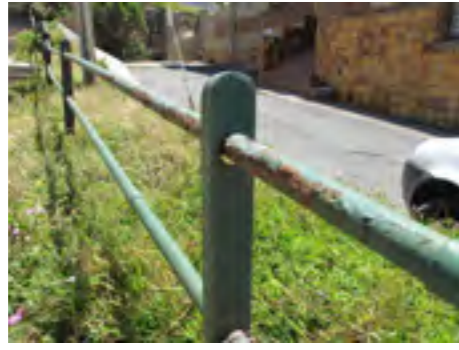
13. Rusted railings need to be replaced.

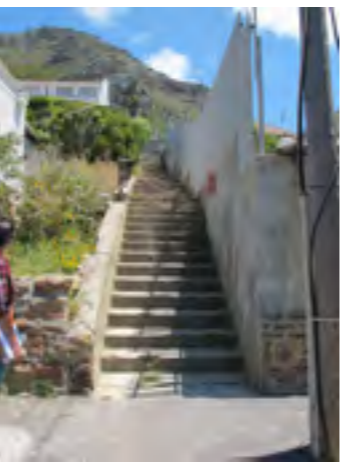
15. Concrete finish on top of brick paving is disintegrating on the stairway and in need of repair.

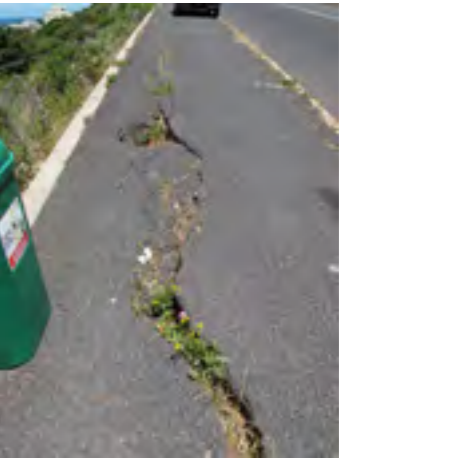
30. Asphalt sidewalk along Boyes Drives is in need of repair.
