KNOW YOUR COAST, 2019

Key findings from over 10 000 sample bacterial tests at 90 sites along 307 km of coastline.

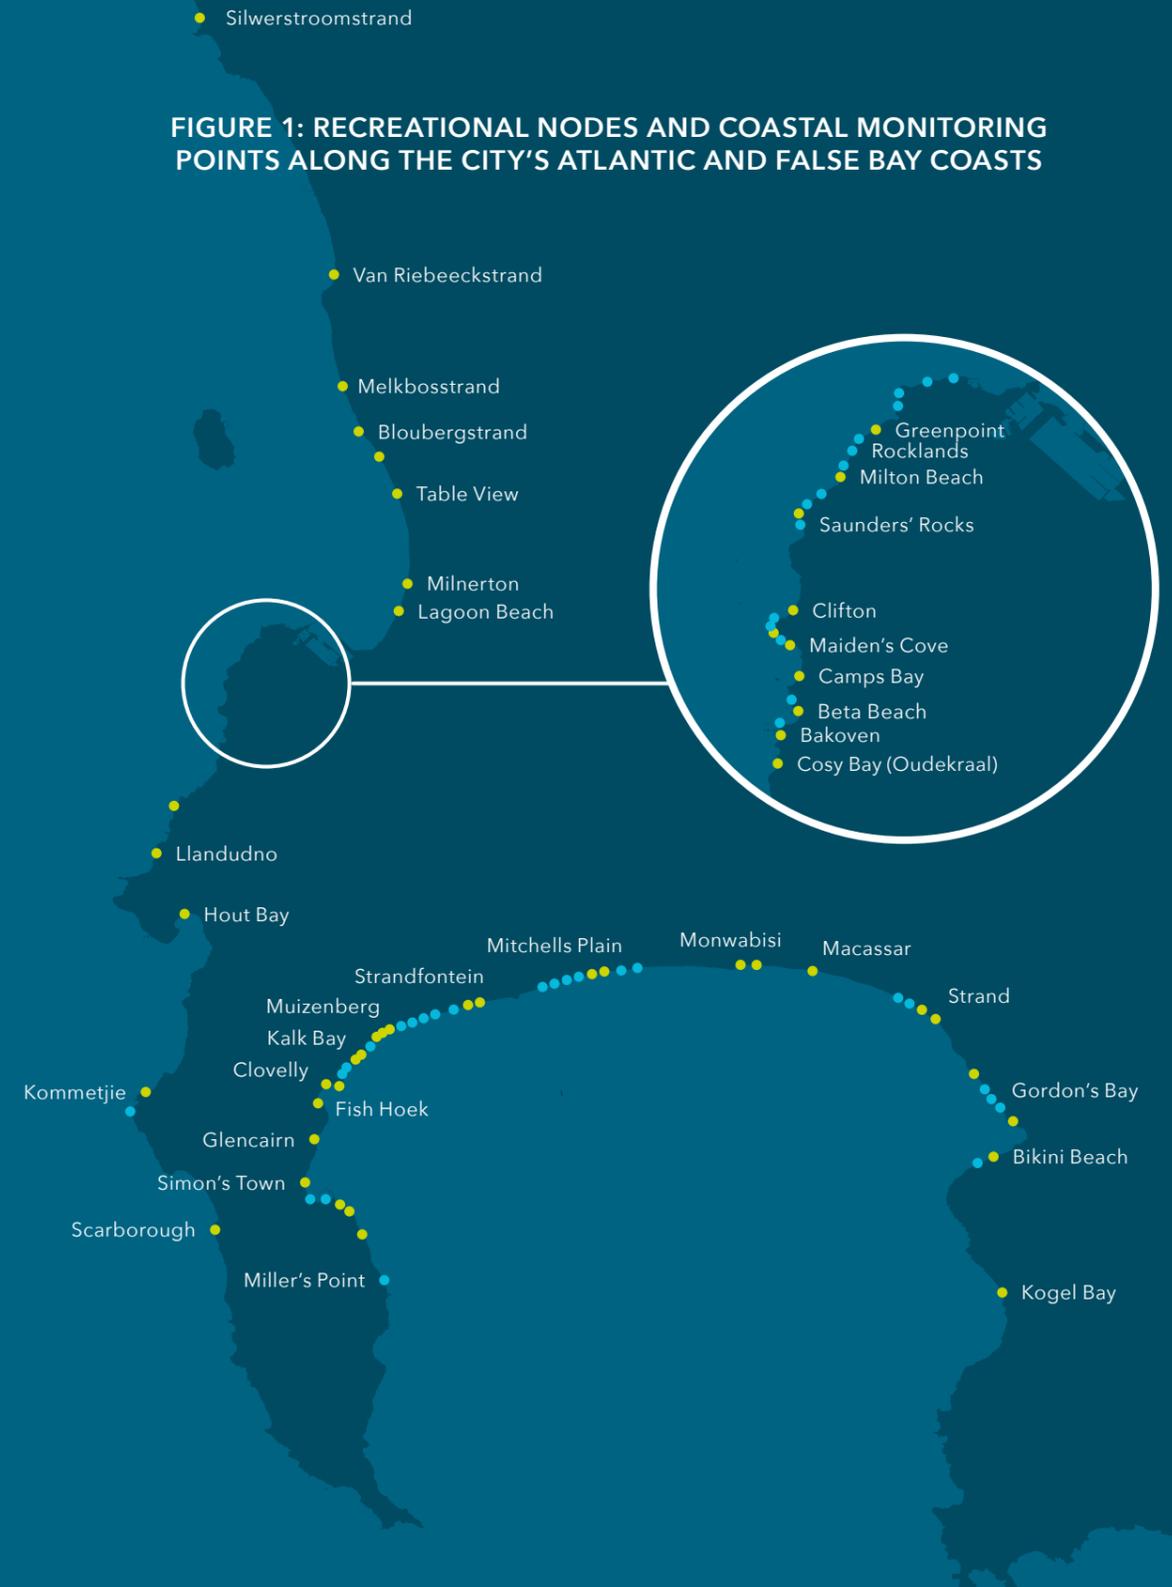
FIGURE 1: RECREATIONAL NODES AND COASTAL MONITORING POINTS ALONG THE CITY'S ATLANTIC AND FALSE BAY COASTS

The City monitors these indicator bacteria in seawater collected at 90 sites between Silverstreamstrand on the Atlantic coast and Kogel Bay on the eastern shore of False Bay (figure 1). Some sites are at popular recreational beaches and in tidal swimming pools - these are known as recreational nodes. Other sites, known as coastal monitoring points, are intentionally positioned near potential or known sources of coastal water pollution (such as stormwater drains and sewer pump stations) to identify the extent of pollution from these sources.

Water samples are collected in the surf zone and in tidal swimming pools, fortnightly. The City's Scientific Services Branch then counts the number of intestinal enterococci and *E. coli* colonies in the water samples. Water quality is assessed by comparing the number of enterococci in the water samples to the South African water quality guidelines for recreational use (table 1). These guidelines are based on research into whether people swimming in waters with different numbers of faecal indicator bacteria developed gastrointestinal illness. They define a "tolerable risk" instead of no risk at all. For most healthy people, water quality that meets the targets will pose little risk to their health, and any illness they might develop will usually be minor and short-lived. This is because humans can usually tolerate exposure to low numbers of pathogens. Toddlers, the elderly, people with weakened immune systems, as well as those that have not previously been exposed to the pathogens are more at risk. People who participate in high-exposure activities such as long-distance swimming and surfing are also at a higher risk, as they are likely to swallow more water than the ordinary person.

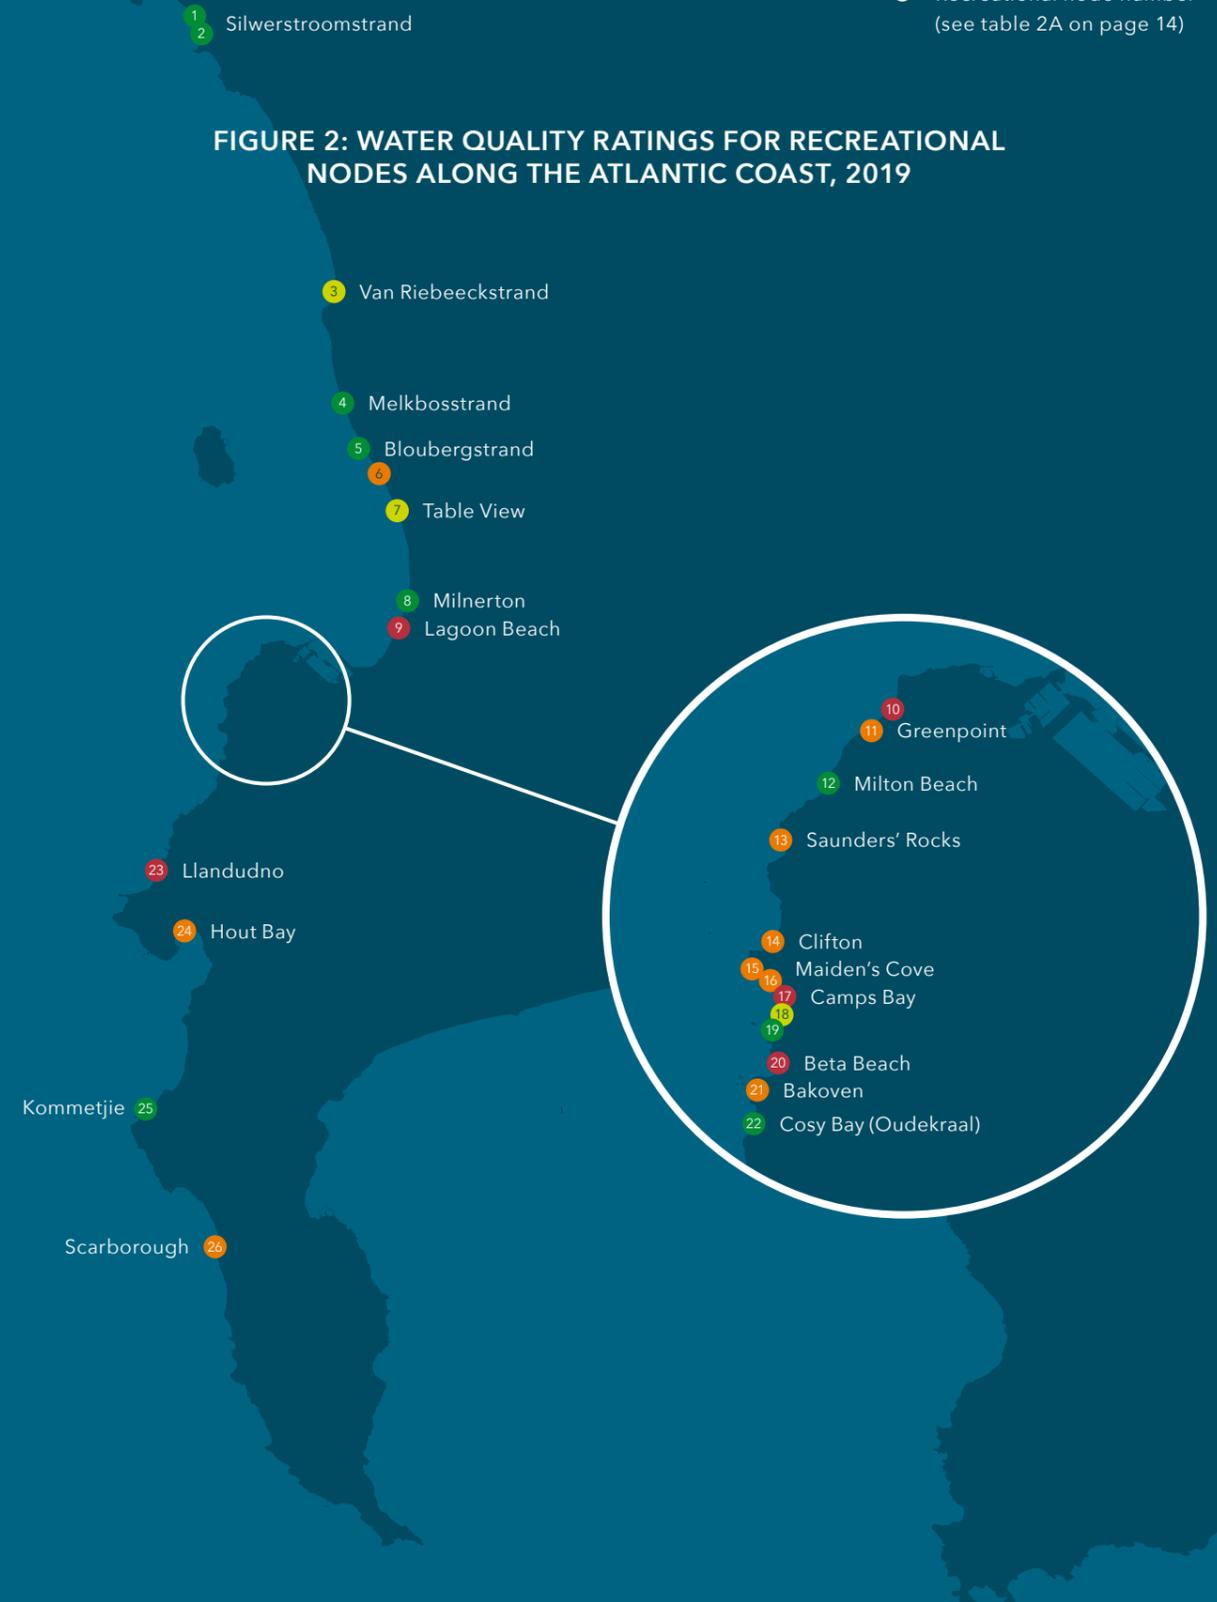
FIGURE 2: WATER QUALITY RATINGS FOR RECREATIONAL NODES ALONG THE ATLANTIC COAST, 2019

Water quality along the Atlantic coast is monitored at 26 recreational nodes and 15 coastal monitoring points (as illustrated in figure 1). Table 2 below provides an overview of water quality at these sites for the past five years (i.e. 2015 to 2019). The water quality rating for recreational nodes in 2019 is illustrated in figure 2.

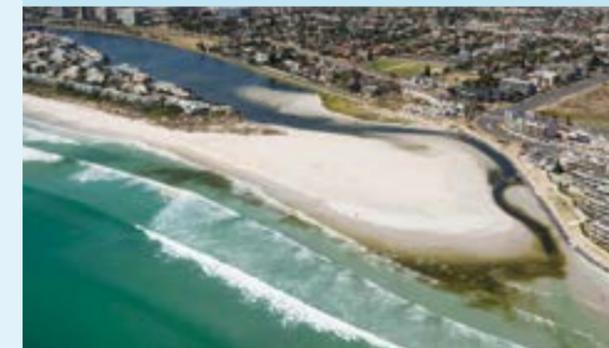
FIGURE 5: INFLOW FROM THE DIEP RIVER, SHOWING TRAPPING IN THE SURF

Lagoon Beach is located at the mouth of the Diep River, which drains a highly polluted catchment (see figure 5). The catchment receives waste and contaminated runoff from a wide range of sources, including agricultural activities in the upper catchment urban runoff from significant urban expansion over the past 15 years, large growth in informal settlements and it is the receiving environment for the treated effluent discharged from the Potsdam wastewater treatment works.

Other contributors include sewer line failures and blockages, sewer pump station overflows and breakages as well as load-shedding causing sewer pump station failures, especially over the past 24 months. Illegal dumping of industrial and household waste in the river and stormwater system remains a problem.

Notably - in the past 12 months, the performance of the wastewater treatment works has been below optimal, contributing significantly to the problem in 2019. Finally, excessive water abstraction for agricultural use in the upper catchment amplifies the pollution levels as effluent from the wastewater treatment works is often the only flow entering the system during drier summer periods.

There are no quick fixes for the pollution problem at Lagoon beach, as the causes are wide and diverse. Improvements in water quality will be gradual, but the City is committed to ongoing improvements through interventions and actions that is in its control. The public can assist the City in improving the water quality at Lagoon beach by refraining from illegal dumping.

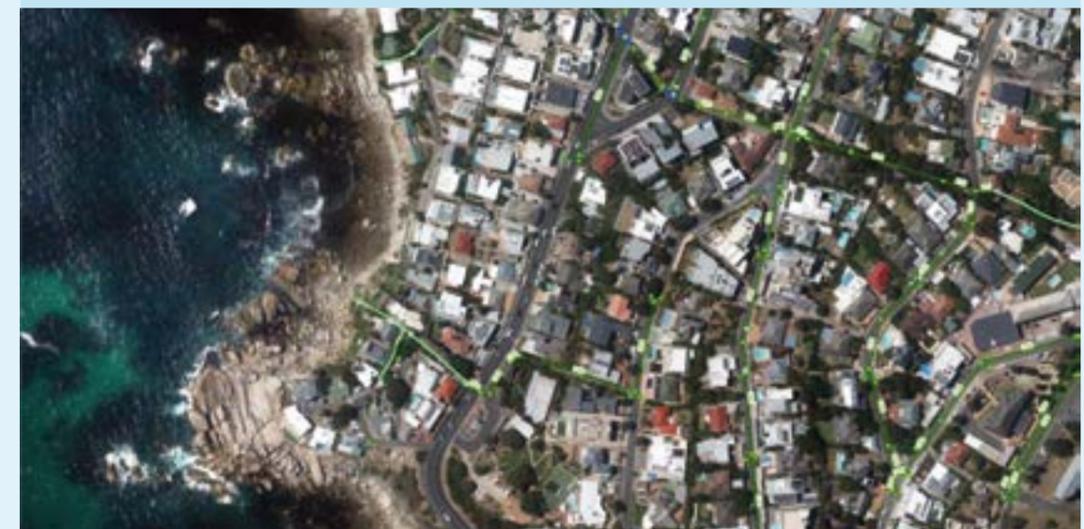
FIGURE 8: STORMWATER DRAINAGE INTO BETA BEACH

A number of stormwater pipes drain into this small, sheltered bay (see figure 8). Similar to Three Anchor Bay, Beta Beach is relatively protected, especially in summer, which results in low dispersion and the trapping of pollutants that enter via the drains. Polluting events appear to be highly variable and depend on infrastructure flows and breakages/outages.

The City is committed to reducing the number of sewer failures across Cape Town, including in the suburb of Bakoven, where Beta Beach is situated.

An updated coastal sewage spill protocol is also in place. In the event of a sewer break, spill or failure, this new protocol will ensure a rapid City response, closing the beach to bathing until such time that laboratory results show a return to normal bacteria counts.

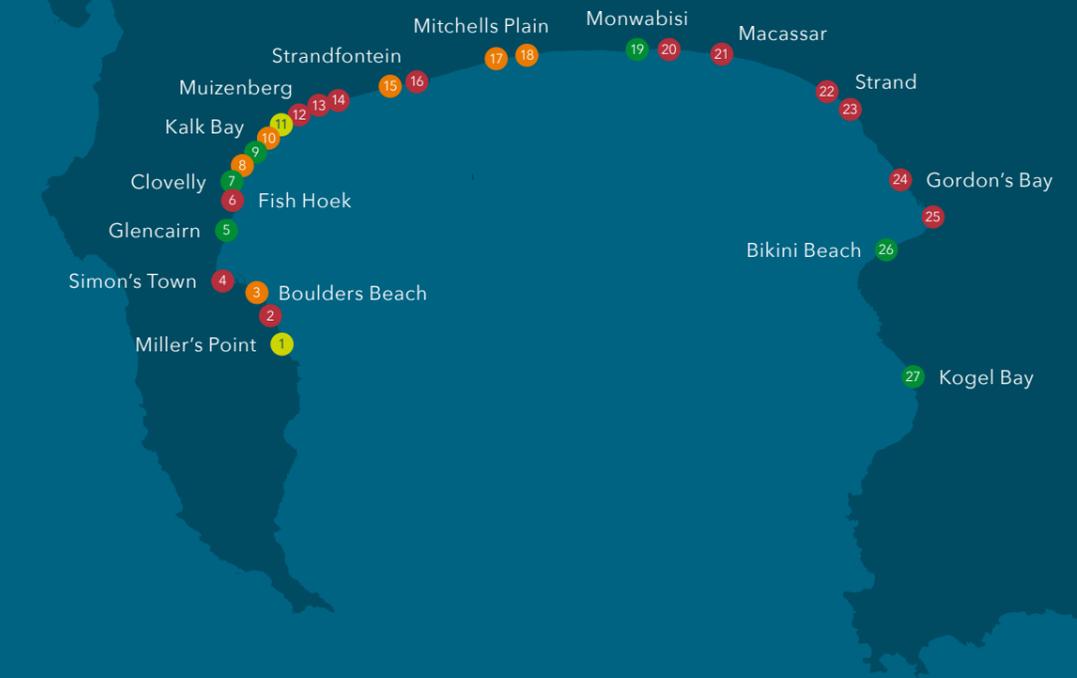
FIGURE 10: WATER QUALITY RATINGS FOR RECREATIONAL NODES ALONG THE FALSE BAY COAST, 2019

Along the False Bay coast, water quality is monitored at 27 recreational nodes and 22 coastal monitoring points (see figure 1 earlier on). Table 4 provides an overview of annual water quality ratings at each of these sites for the past five years (2015 to 2019). The water quality rating for recreational nodes in 2019 is illustrated in figure 9 below.

However, water quality at 11 sites along the False Bay coast was rated “poor” in 2019, accounting for 41% of the recreational nodes in this area. These sites were mostly concentrated in the north-eastern (Monwabisi, Macassar, Strand and Gordon’s Bay) and north-western (Fish Hoek and Sunrise Beach) parts of the bay (see figure 10). Water quality at beaches in the north-east has also regressed over the past five years. The situation at these beaches is explored in greater detail below.

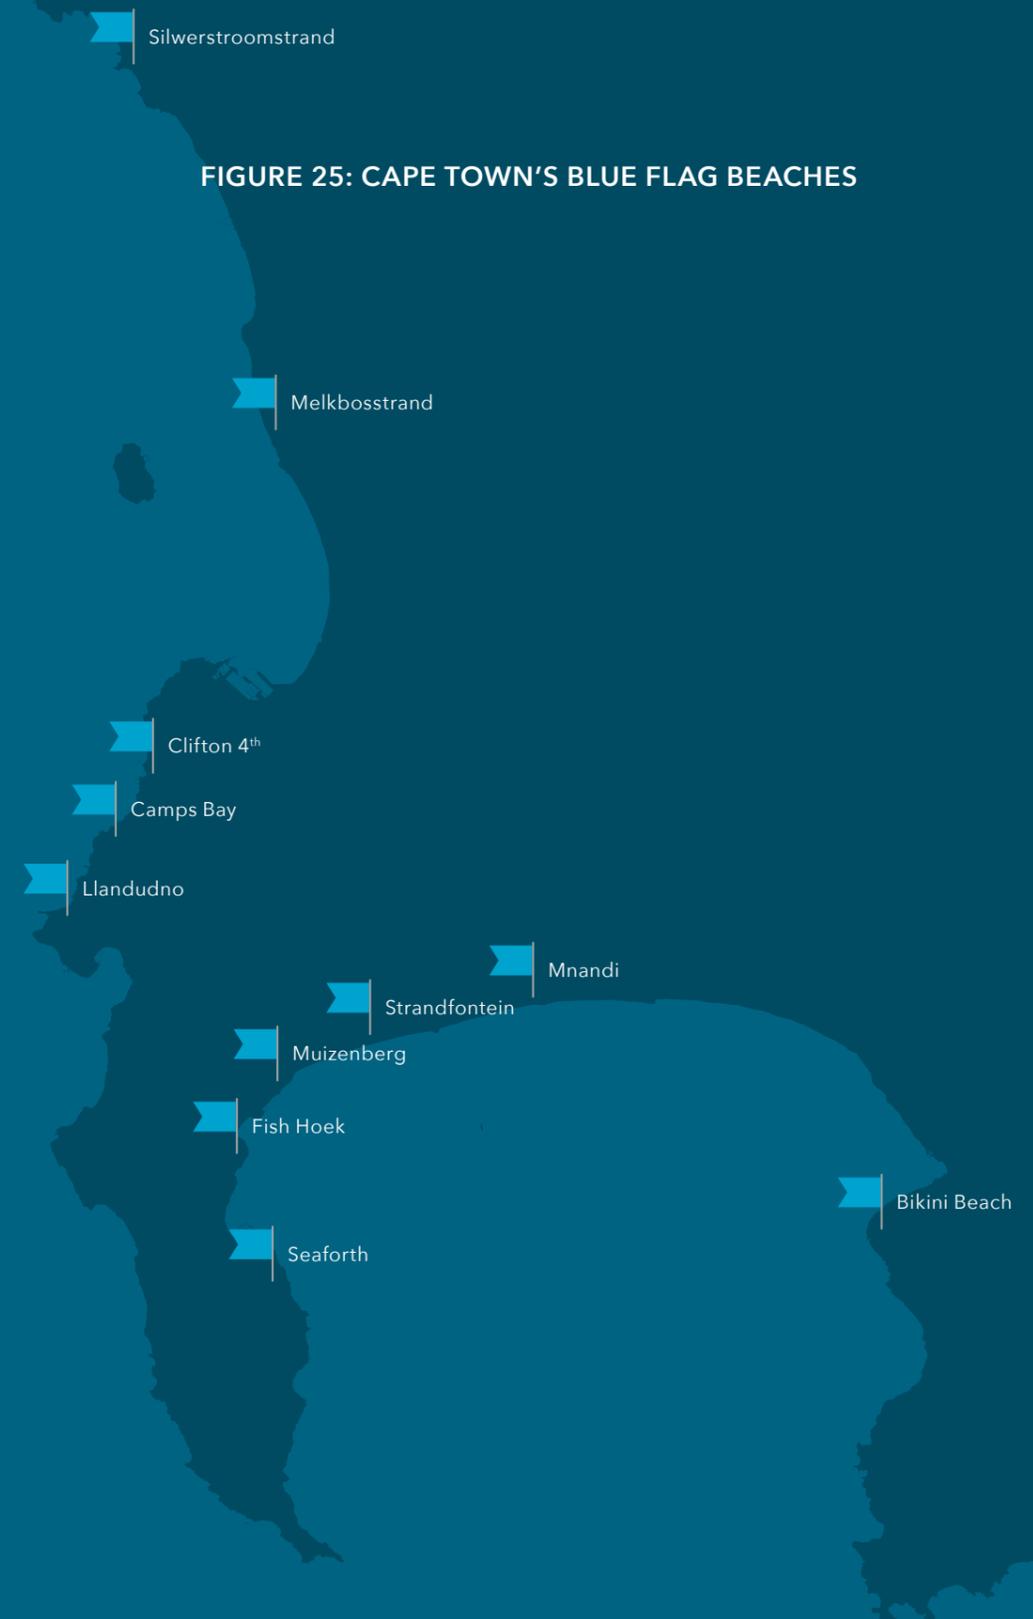
FIGURE 25: CAPE TOWN'S BLUE FLAG BEACHES

Ten beaches in Cape Town currently have Blue Flag status, while one (Seaforth) has pilot status (see figure 25). Water quality at these beaches is monitored in accordance with Blue Flag programme specifications. Samples are collected regularly during the bathing season (1 November to 31 March) and analysed for enterococci and *E. coli*. Sample collection and analysis is performed by an independent organisation.

Key here is that Blue Flag status in Cape Town is awarded on a seasonal basis, for the period 1 December to 31 March. Water quality is assessed from the month before the Blue Flag season, and monthly throughout the season. This means that, in Cape Town, Blue Flag status is awarded based on water quality results for the summer season only, when the frequency of poorer results tends to be far lower, primarily due to significantly reduced or absent rainfall events.
