# KNOW YOUR COAST, 2020

Key findings from over 10 000 sample bacterial  
tests at 99 sites along 307 km of coastline.

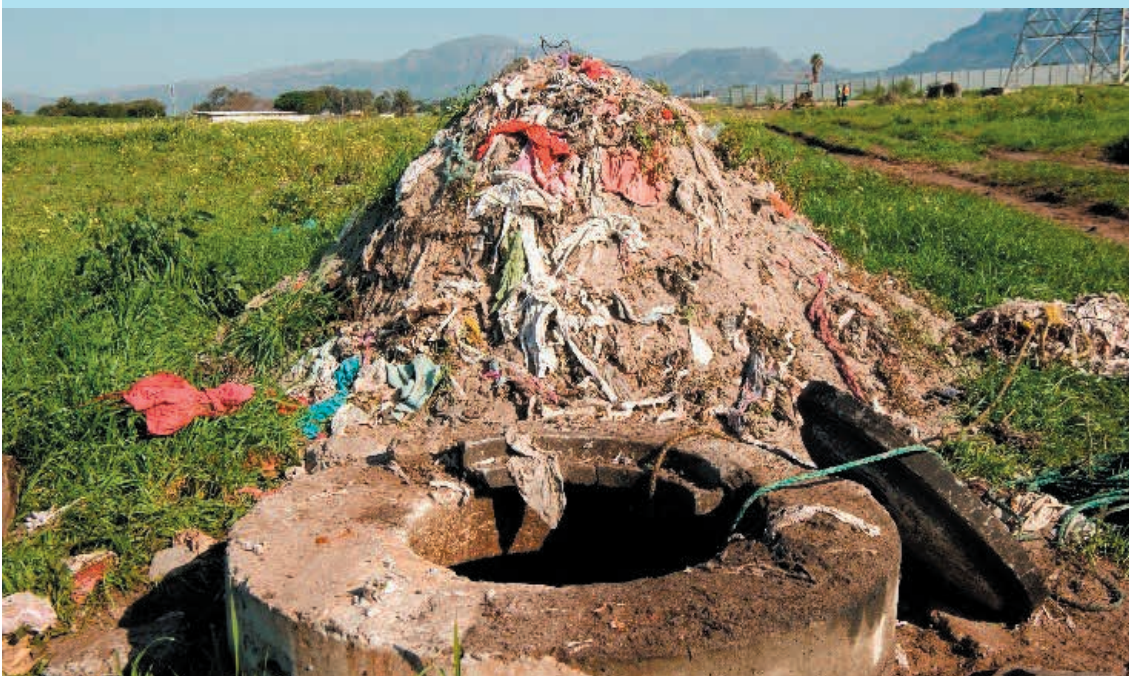
FIGURE 1: FOREIGN MATERIALS REMOVED FROM THE CITY'S SEWER SYSTEM

Every day, the City has to deal with the domestic wastewater, solid waste and contaminated stormwater runoff generated by Cape Town's four million people, and another one million bordering the city. This amounts to approximately 500 megalitres per day of wastewater within the city, while our catchments also discharge effluents and contamination from neighbouring municipalities. In addition to this, the City can respond to up to 400 sewer system failures each day. During 2020, the City's Water and Sanitation Department cleared approximately 122 000 sewer blockages across Cape Town, the primary cause (75%) being misuse of the system, including the illegal disposal of foreign materials into the sewer system (figure 1). More than R350 million was spent on efforts to address this chronic - yet largely avoidable - problem. Refer to the section on 'Coastal water quality - how you can help make a difference' that provides more information on this aspect, and identifies ways in which the public may be able to assist in preventing this phenomenon. As activities in catchments may impact coastal waters, and to better understand the water-quality dynamics more holistically in Cape Town, this report is best read in conjunction with the [INLAND WATER QUALITY REPORT](#) that provides further information on matters relating to water quality in catchments.

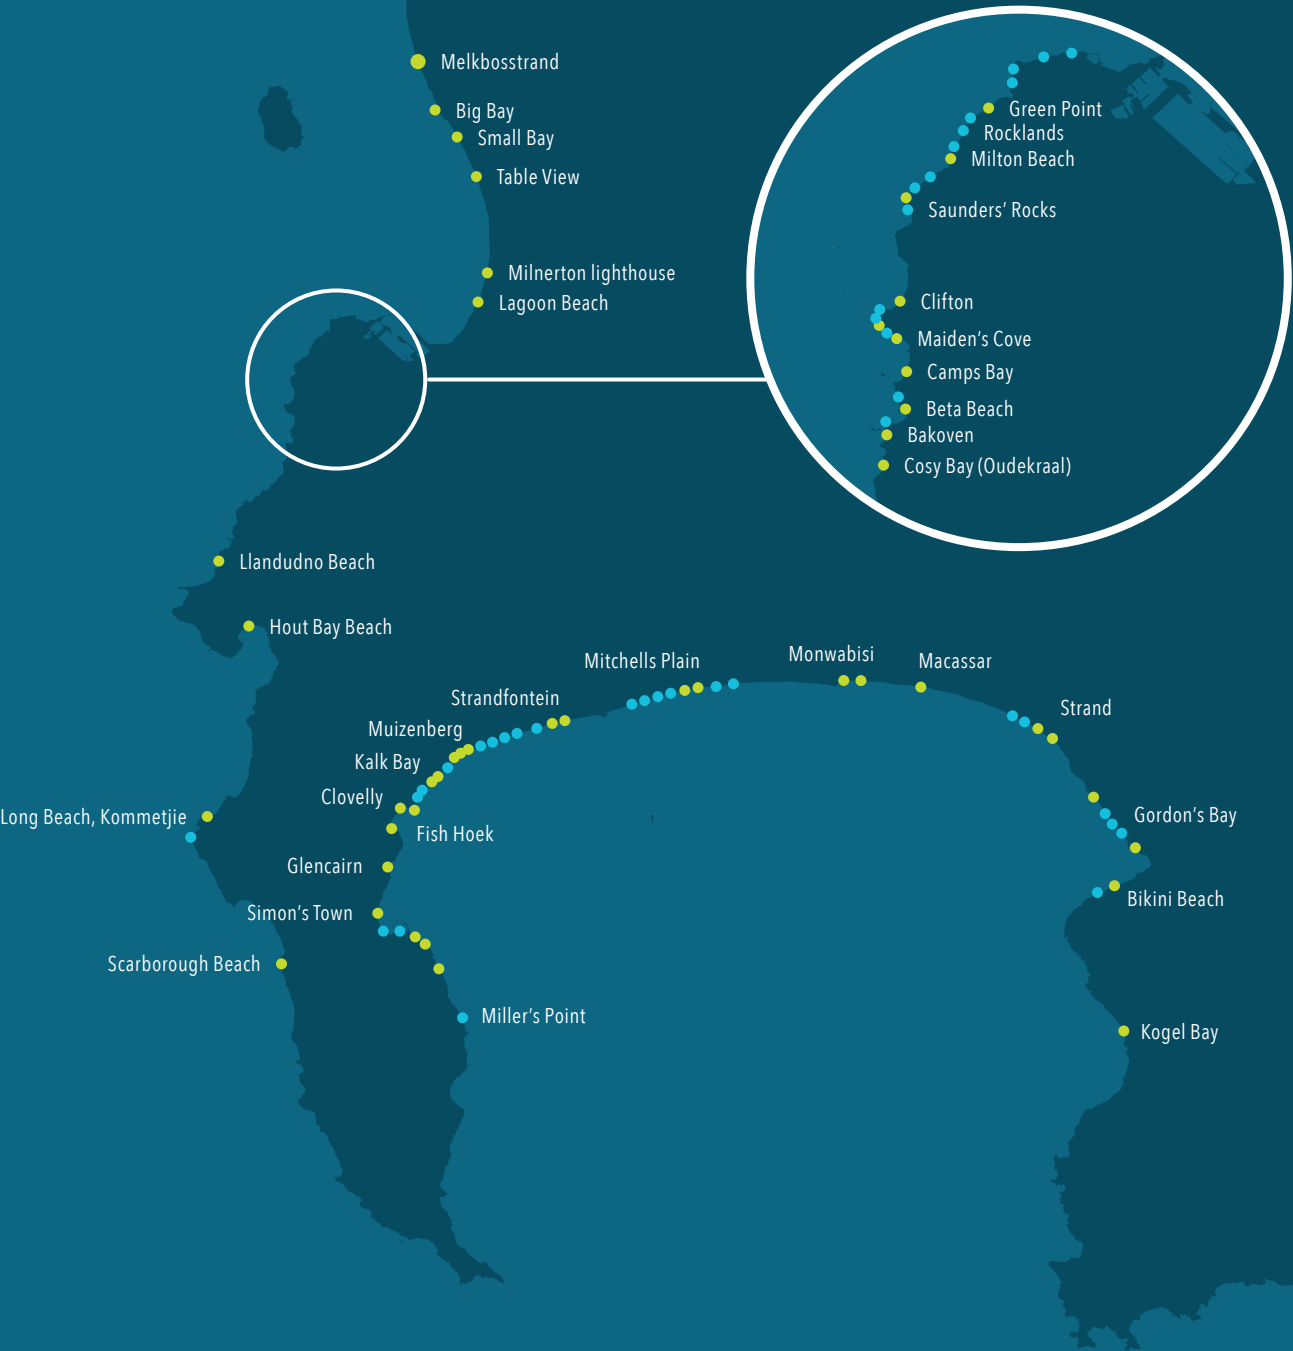
**FIGURE 2: RECREATIONAL NODES AND COASTAL MONITORING POINTS ALONG THE CITY'S ATLANTIC AND FALSE BAY COASTS**

Water samples are collected in the surf zone and in tidal swimming pools, fortnightly. The City's Scientific Services Branch then counts the number of intestinal enterococci and *E. coli* colonies in the water samples. Water quality is assessed by comparing the number of enterococci in the water samples and measured against the guidelines determined by the South African Water-Quality Guidelines for Coastal Marine Waters (table 1). These [guidelines](#), determined by the then National Department of Water Affairs and Forestry, are based on research into whether people swimming in waters with different amounts of faecal indicator bacteria developed gastrointestinal illness. The guidelines apply a risk-adjusted approach whereby a 'tolerable risk' instead of 'no risk' at all is determined. For most healthy people, water quality that meets the targets will pose little risk to their health, and any illness they might develop will usually be minor and short-lived. This is because humans can usually tolerate exposure to low numbers of pathogens. Toddlers, the elderly, people with weakened immune systems and those that have not previously been exposed to the pathogens are more at risk. People who participate in high-exposure activities such as long-distance swimming and surfing are also at a higher risk, as they are likely to swallow more water than the ordinary person.

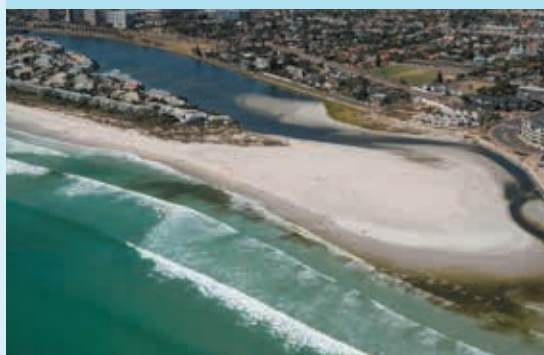
FIGURE 7: INFLOW FROM THE DIEP RIVER, SHOWING TRAPPING IN THE SURF

Other contributing factors include sewer line failures and blockages, sewer pump station overflows and breakages, as well as load-shedding causing sewer pump station failures, especially over the past 36 months. Illegal dumping of industrial and household waste in the river and stormwater system remains a problem.

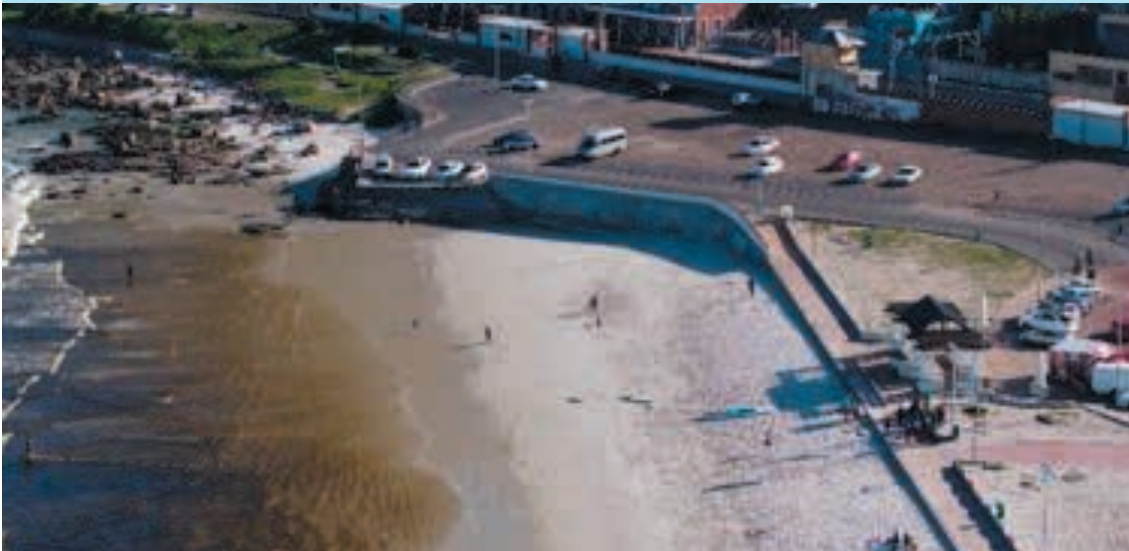
FIGURE 19: DIATOM BLOOM AT SURFERS CORNER, MUIZENBERG

*A. australis* forms distinctive dark reddish-brown patches that have been studied extensively at Sundays River Beach, Algoa Bay, with research underway at Muizenberg Beach, False Bay. The other species of surf zone diatom found in South Africa, *A. glacialis*, forms patches similar to that of *A. australis* but has only been sighted and recorded on a single occasion at Sundays River Beach.

Generally, diatoms (including some surf zone diatoms) form patches through rapid asexual reproduction via cell division; these high-density patches are called 'blooms'. However, in the case of *A. australis*, cell division only accounts for a maximum of 21% of the growth of the population during these patch events (Talbot & Bate, 1986). The current hypothesis is that these patches are the result of vertical migration of cells in the water column combined with the influence of physical features and water circulation in the surf zone area. Common physical features of beaches where these patches occur are wide surf zones with medium- to high-energy wave action, well-developed rip currents, and proximity to dunes overlying nutrient-rich aquifers (Campbell & Bate, 1997).

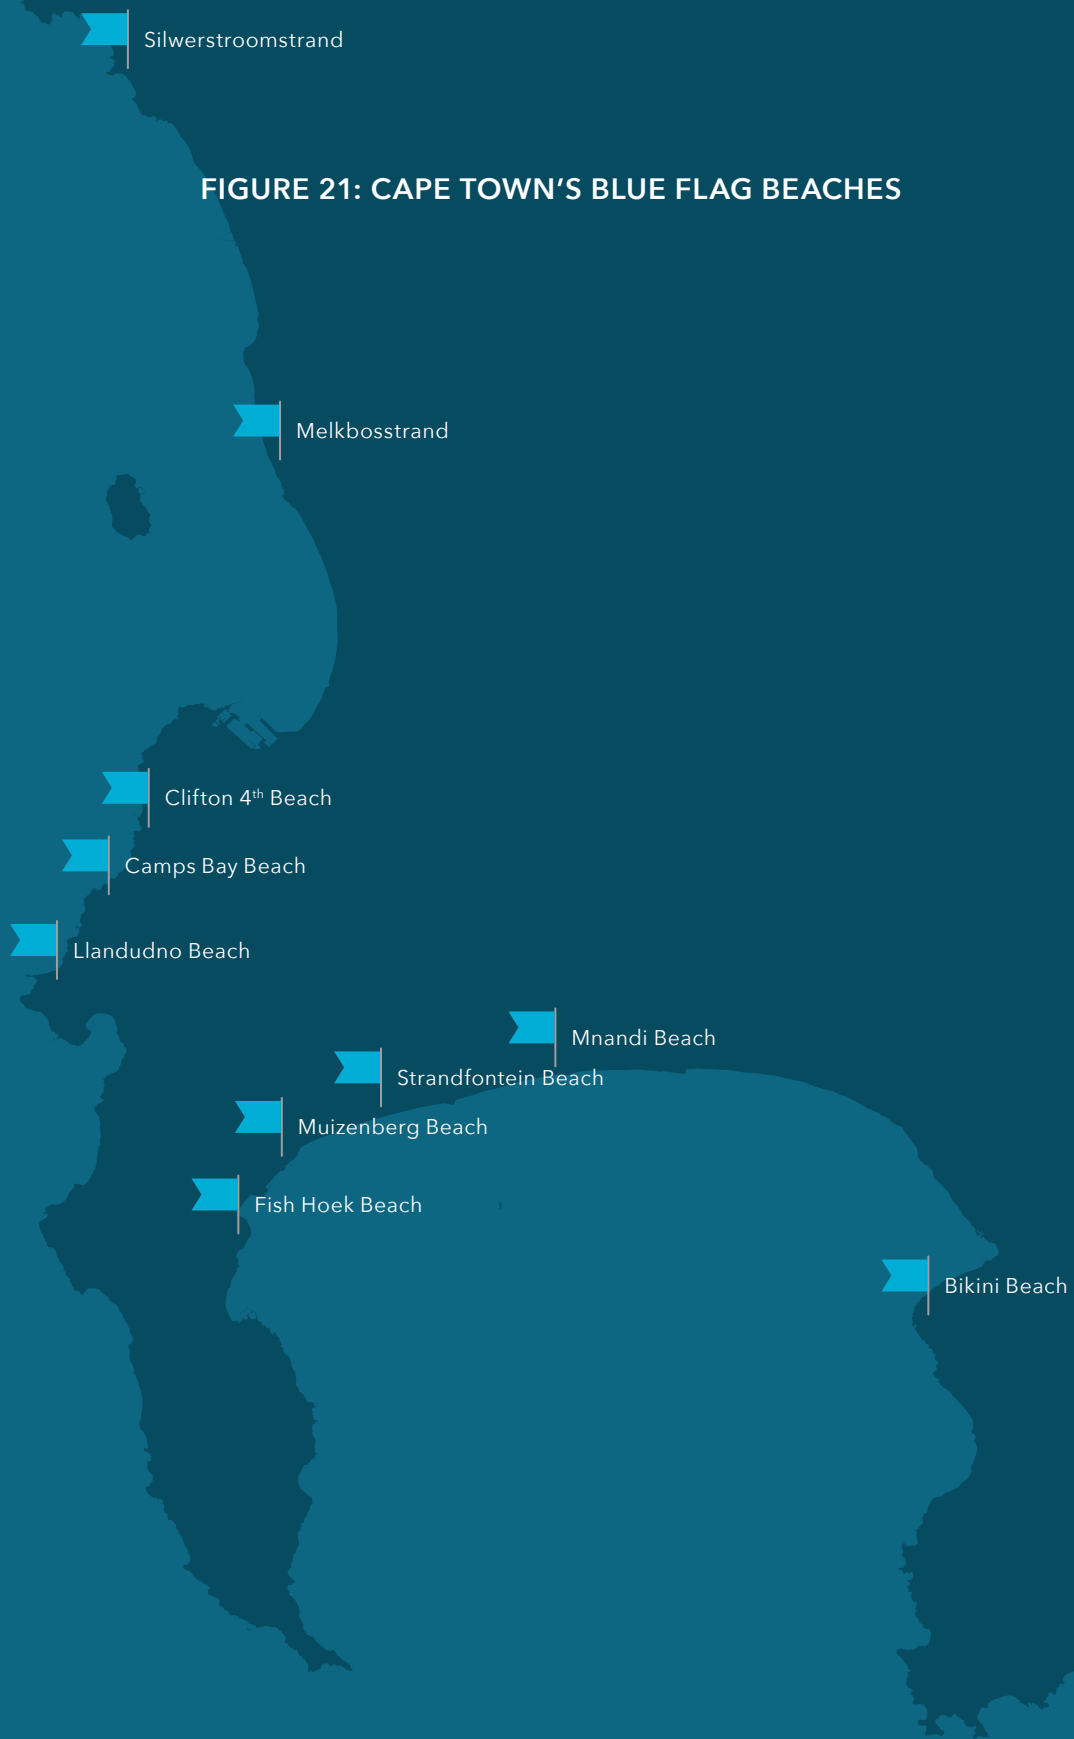
FIGURE 21: CAPE TOWN'S BLUE FLAG BEACHES

The City currently has 10 Blue Flag beaches, with five each on the Atlantic and False Bay coastlines (table 13 and figure 21). In accordance with the international Blue Flag standards, each beach has to submit at least five samples per season, no more than 30 days apart. It is very important to note that the Blue Flag season is only from 1 December to 31 January for most of the beaches. For more popular beaches (Camps Bay, Muizenberg and Strandfontein), Blue Flag season continues until 31 March. With a season of four months, a sample must be taken every month in addition to a pre-season sample, and this equates to five samples per year. However, the City exceeds this sampling regime, as we obtain weekly or biweekly samples necessary for the beaches that only have a two-month season.

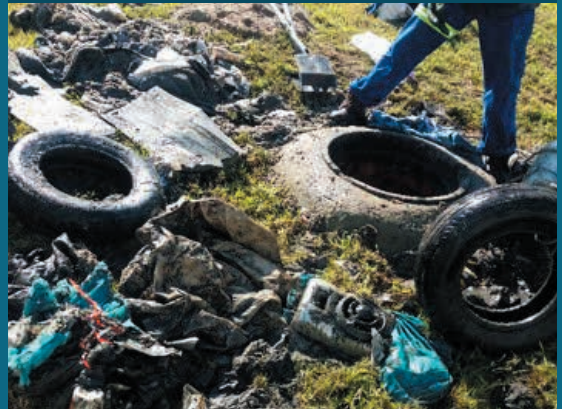
FIGURE 23: FOREIGN MATERIAL, INCLUDING TYRES AND A GAS COOKER, REMOVED FROM THE SEWER SYSTEM

The City spent approximately R350 million last year specifically due to misuse of the system. This is expenditure that can be avoided through improved awareness and education, and gradual behaviour change. Members of the public can contribute to limiting sewage blockages and subsequent spills into the receiving environment by doing the following:

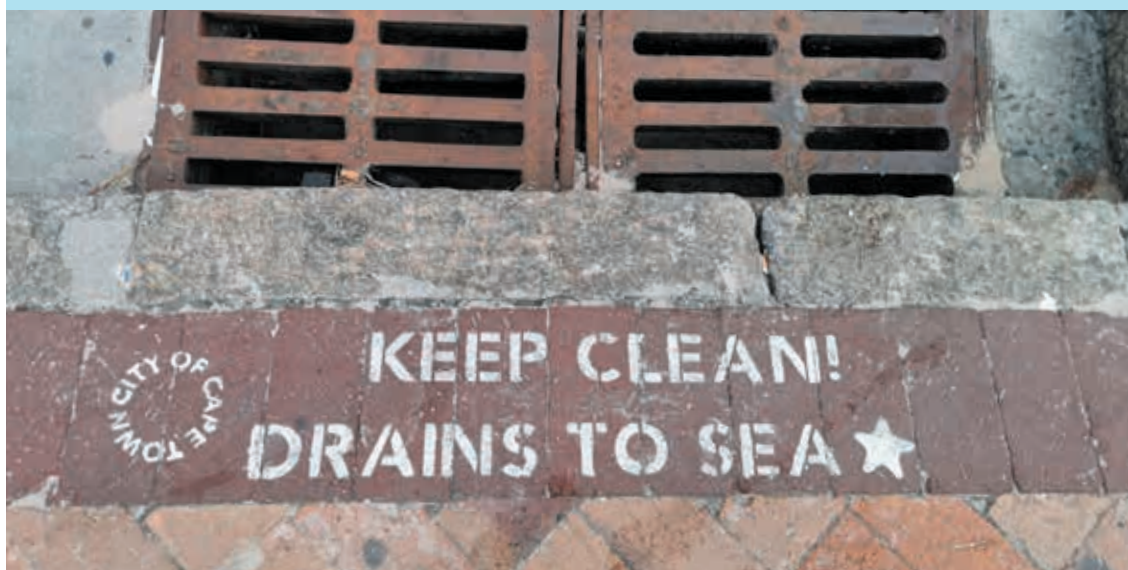
FIGURE 24: STORMWATER STENCILLING: KEEP CLEAN! DRAINS TO SEA

Approximately 70 stencils have been painted to date at these locations (figure 24) but the project has been delayed as a consequence of beach closures due to the Covid lockdown.
