MUIZENBERG PEDESTRIAN TOURISM ROUTES

CONTENTS PAGE

METHODOLOGY

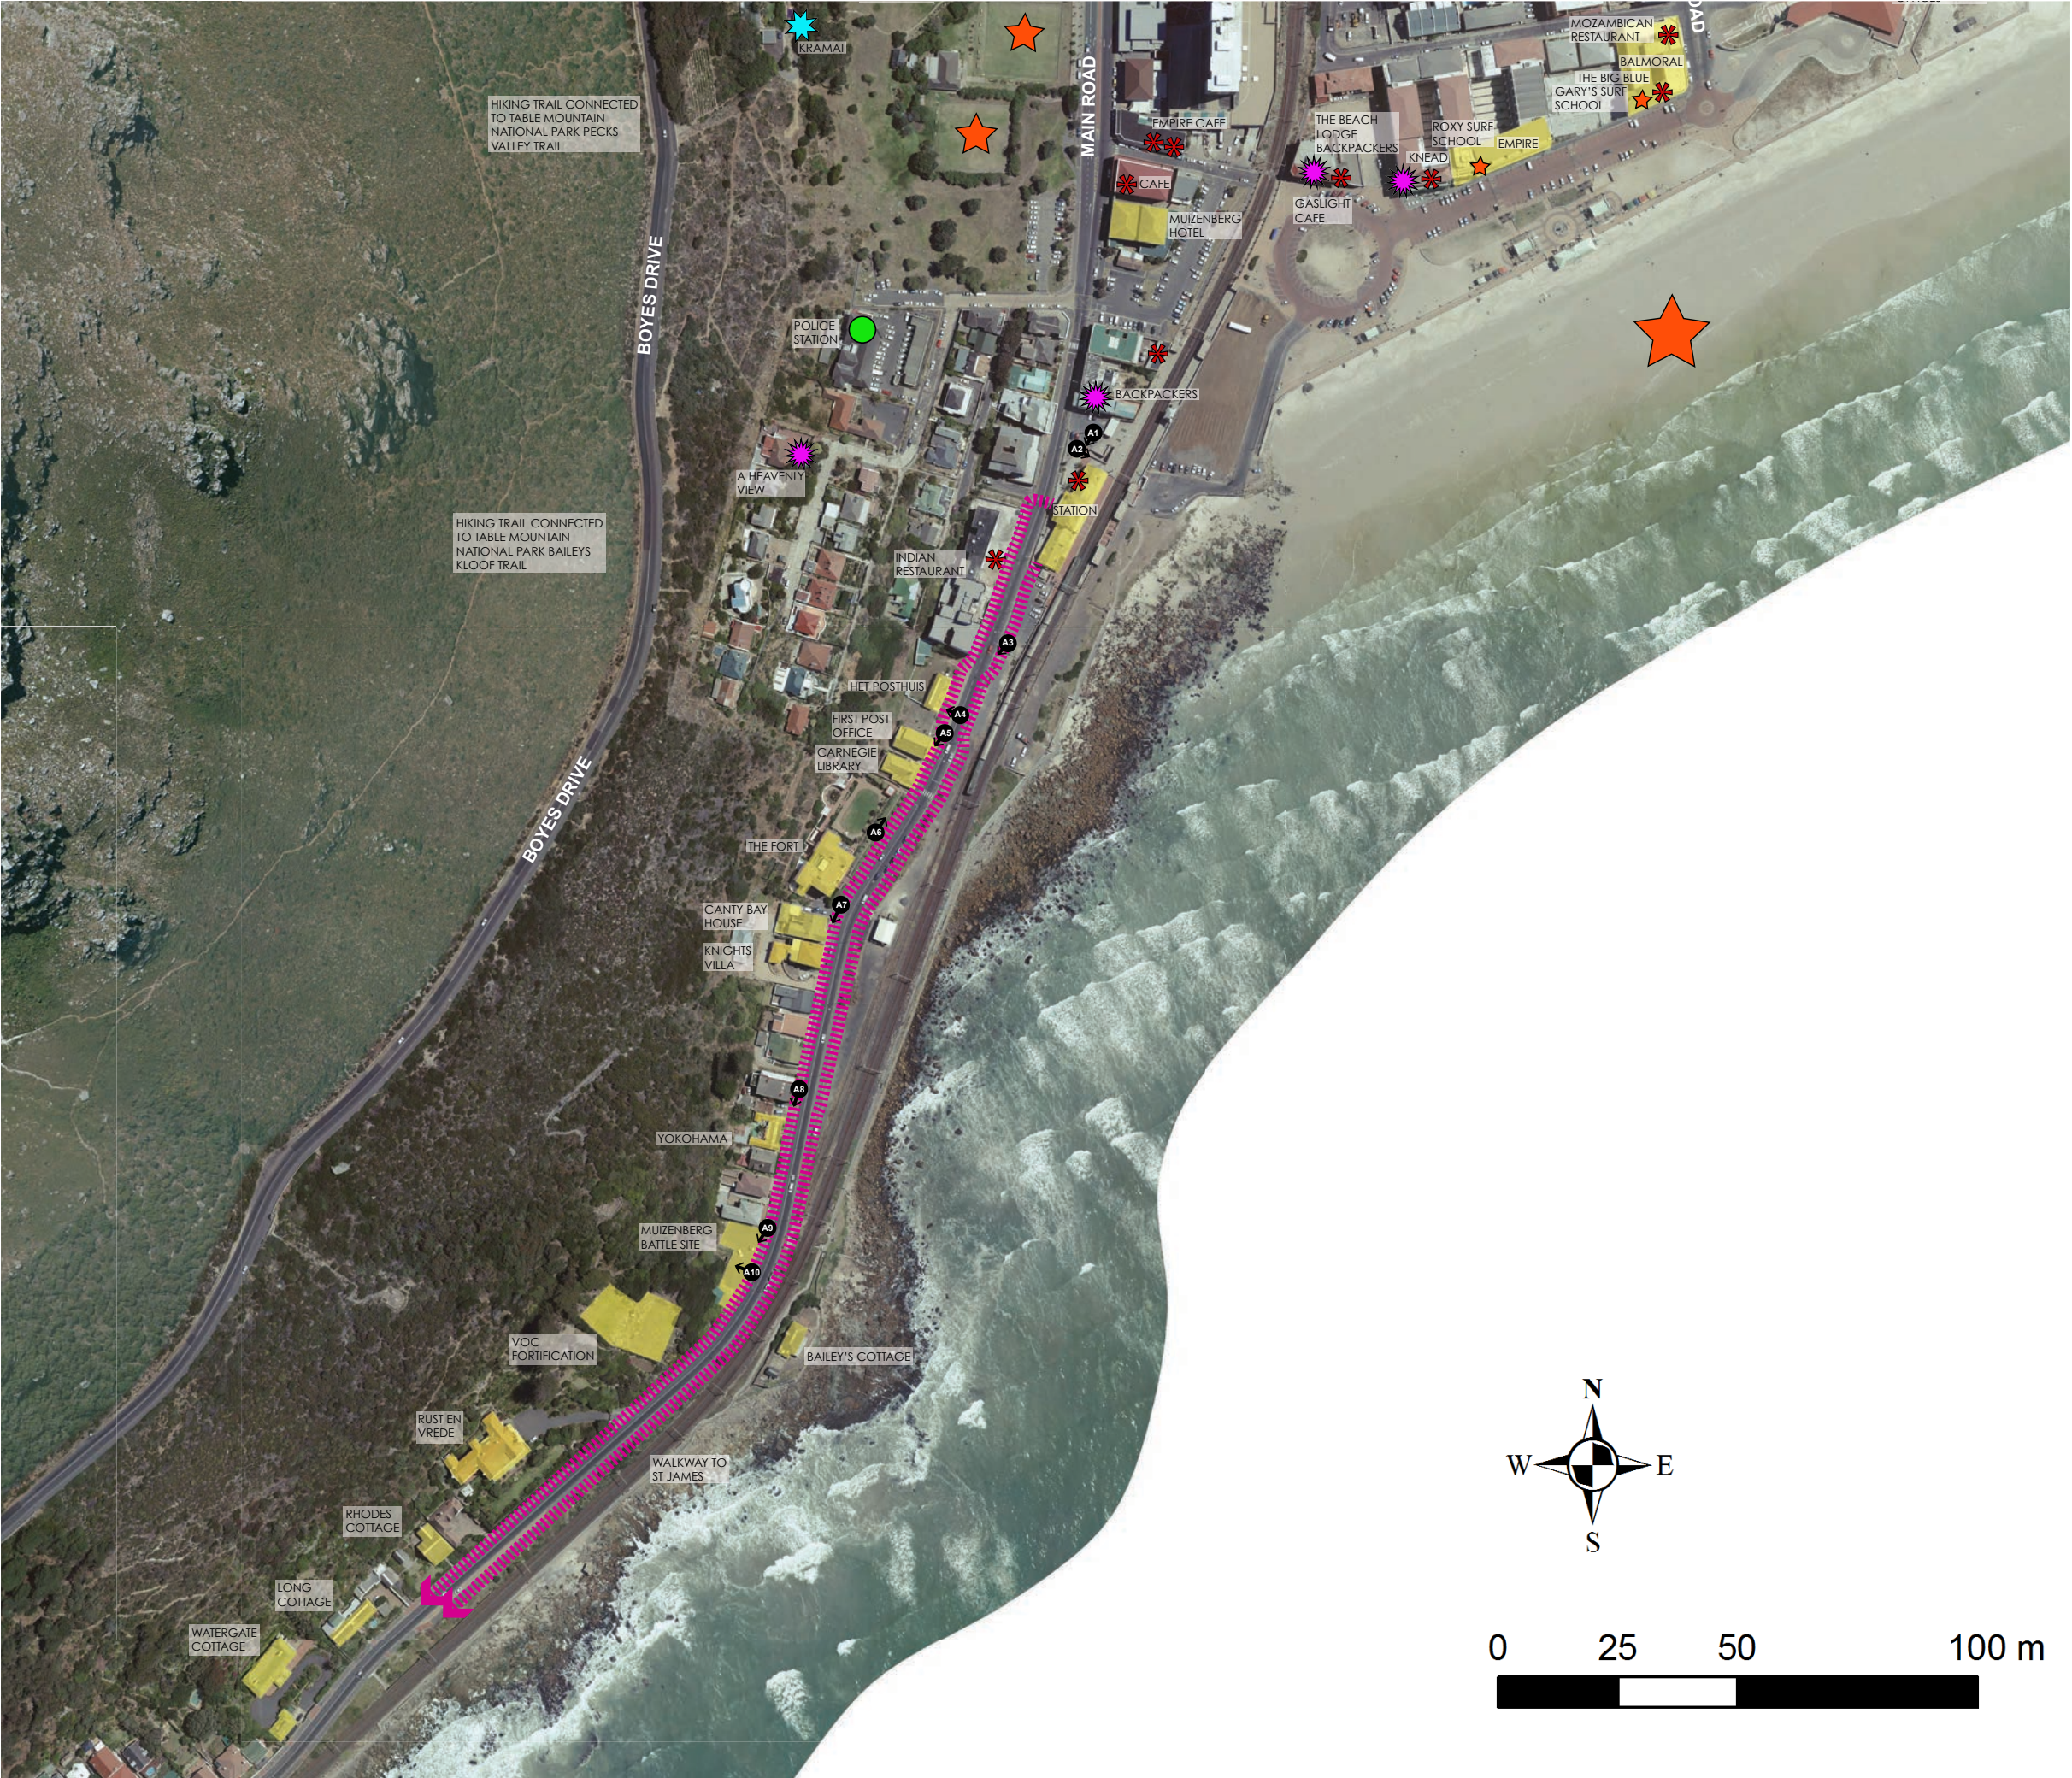
ROUTE A_HISTORICAL BUILDINGS AND BATTLE SITE ALONG BEACH ROAD

The historical route extends from the Muizenberg Station southwards along the sidewalk in Beach Road towards St James. There are a number of historical buildings along this route, including the Muizenberg Battlefield site, Het Posthuys and Rhodes Cottage. The sidewalk has recently been upgraded and is in good condition. The sidewalk is an asphalt surface with red brick paving and cobbles used to celebrate historical entrances. the historical stone kerbing has been retained.

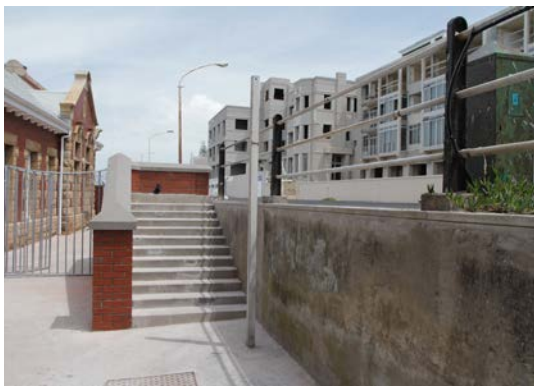
1. The station precinct was recently upgraded. The entrance is uncluttered. The coping on the walls have been recently repaired.

There is poor provision for wheelchair access, low walls cross the pathway at the entrance.

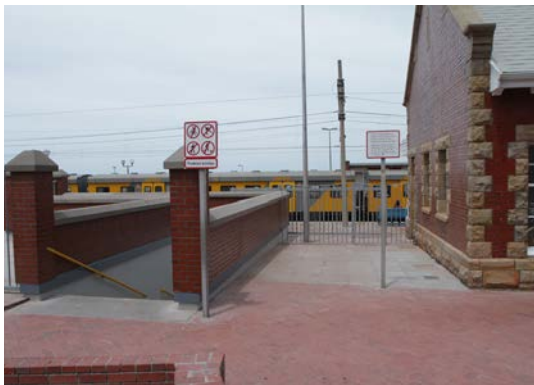
2. There are multiple signboards in close proximity that could form part of one signage board. Some signage dealing with traditional weapons is inappropriate in this precinct

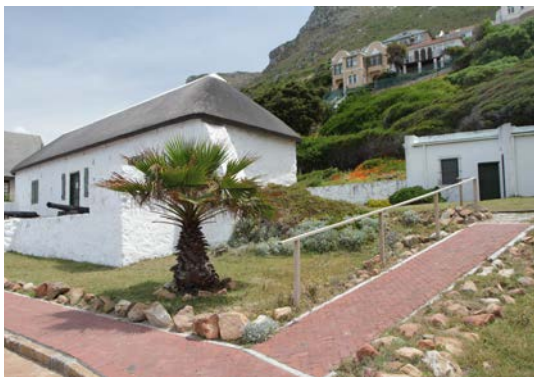
3. Paving along the sidewalk at Het Posthuis is in good condition, red brick with cobble edging is used to indicate historical significance. Historical stone kerbing has been retained along the sidewalk.

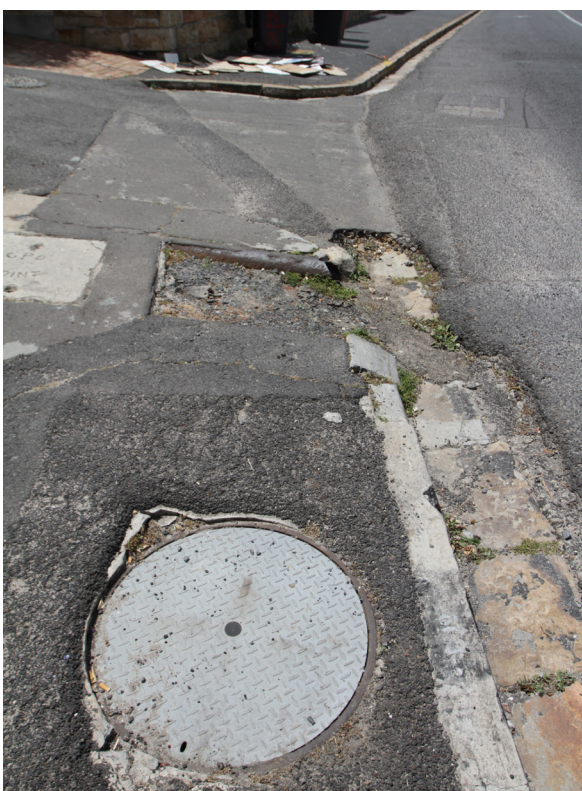
7. The asphalt pavement is broken and patched. The badly rusted light post outside the station should be removed and replaced.

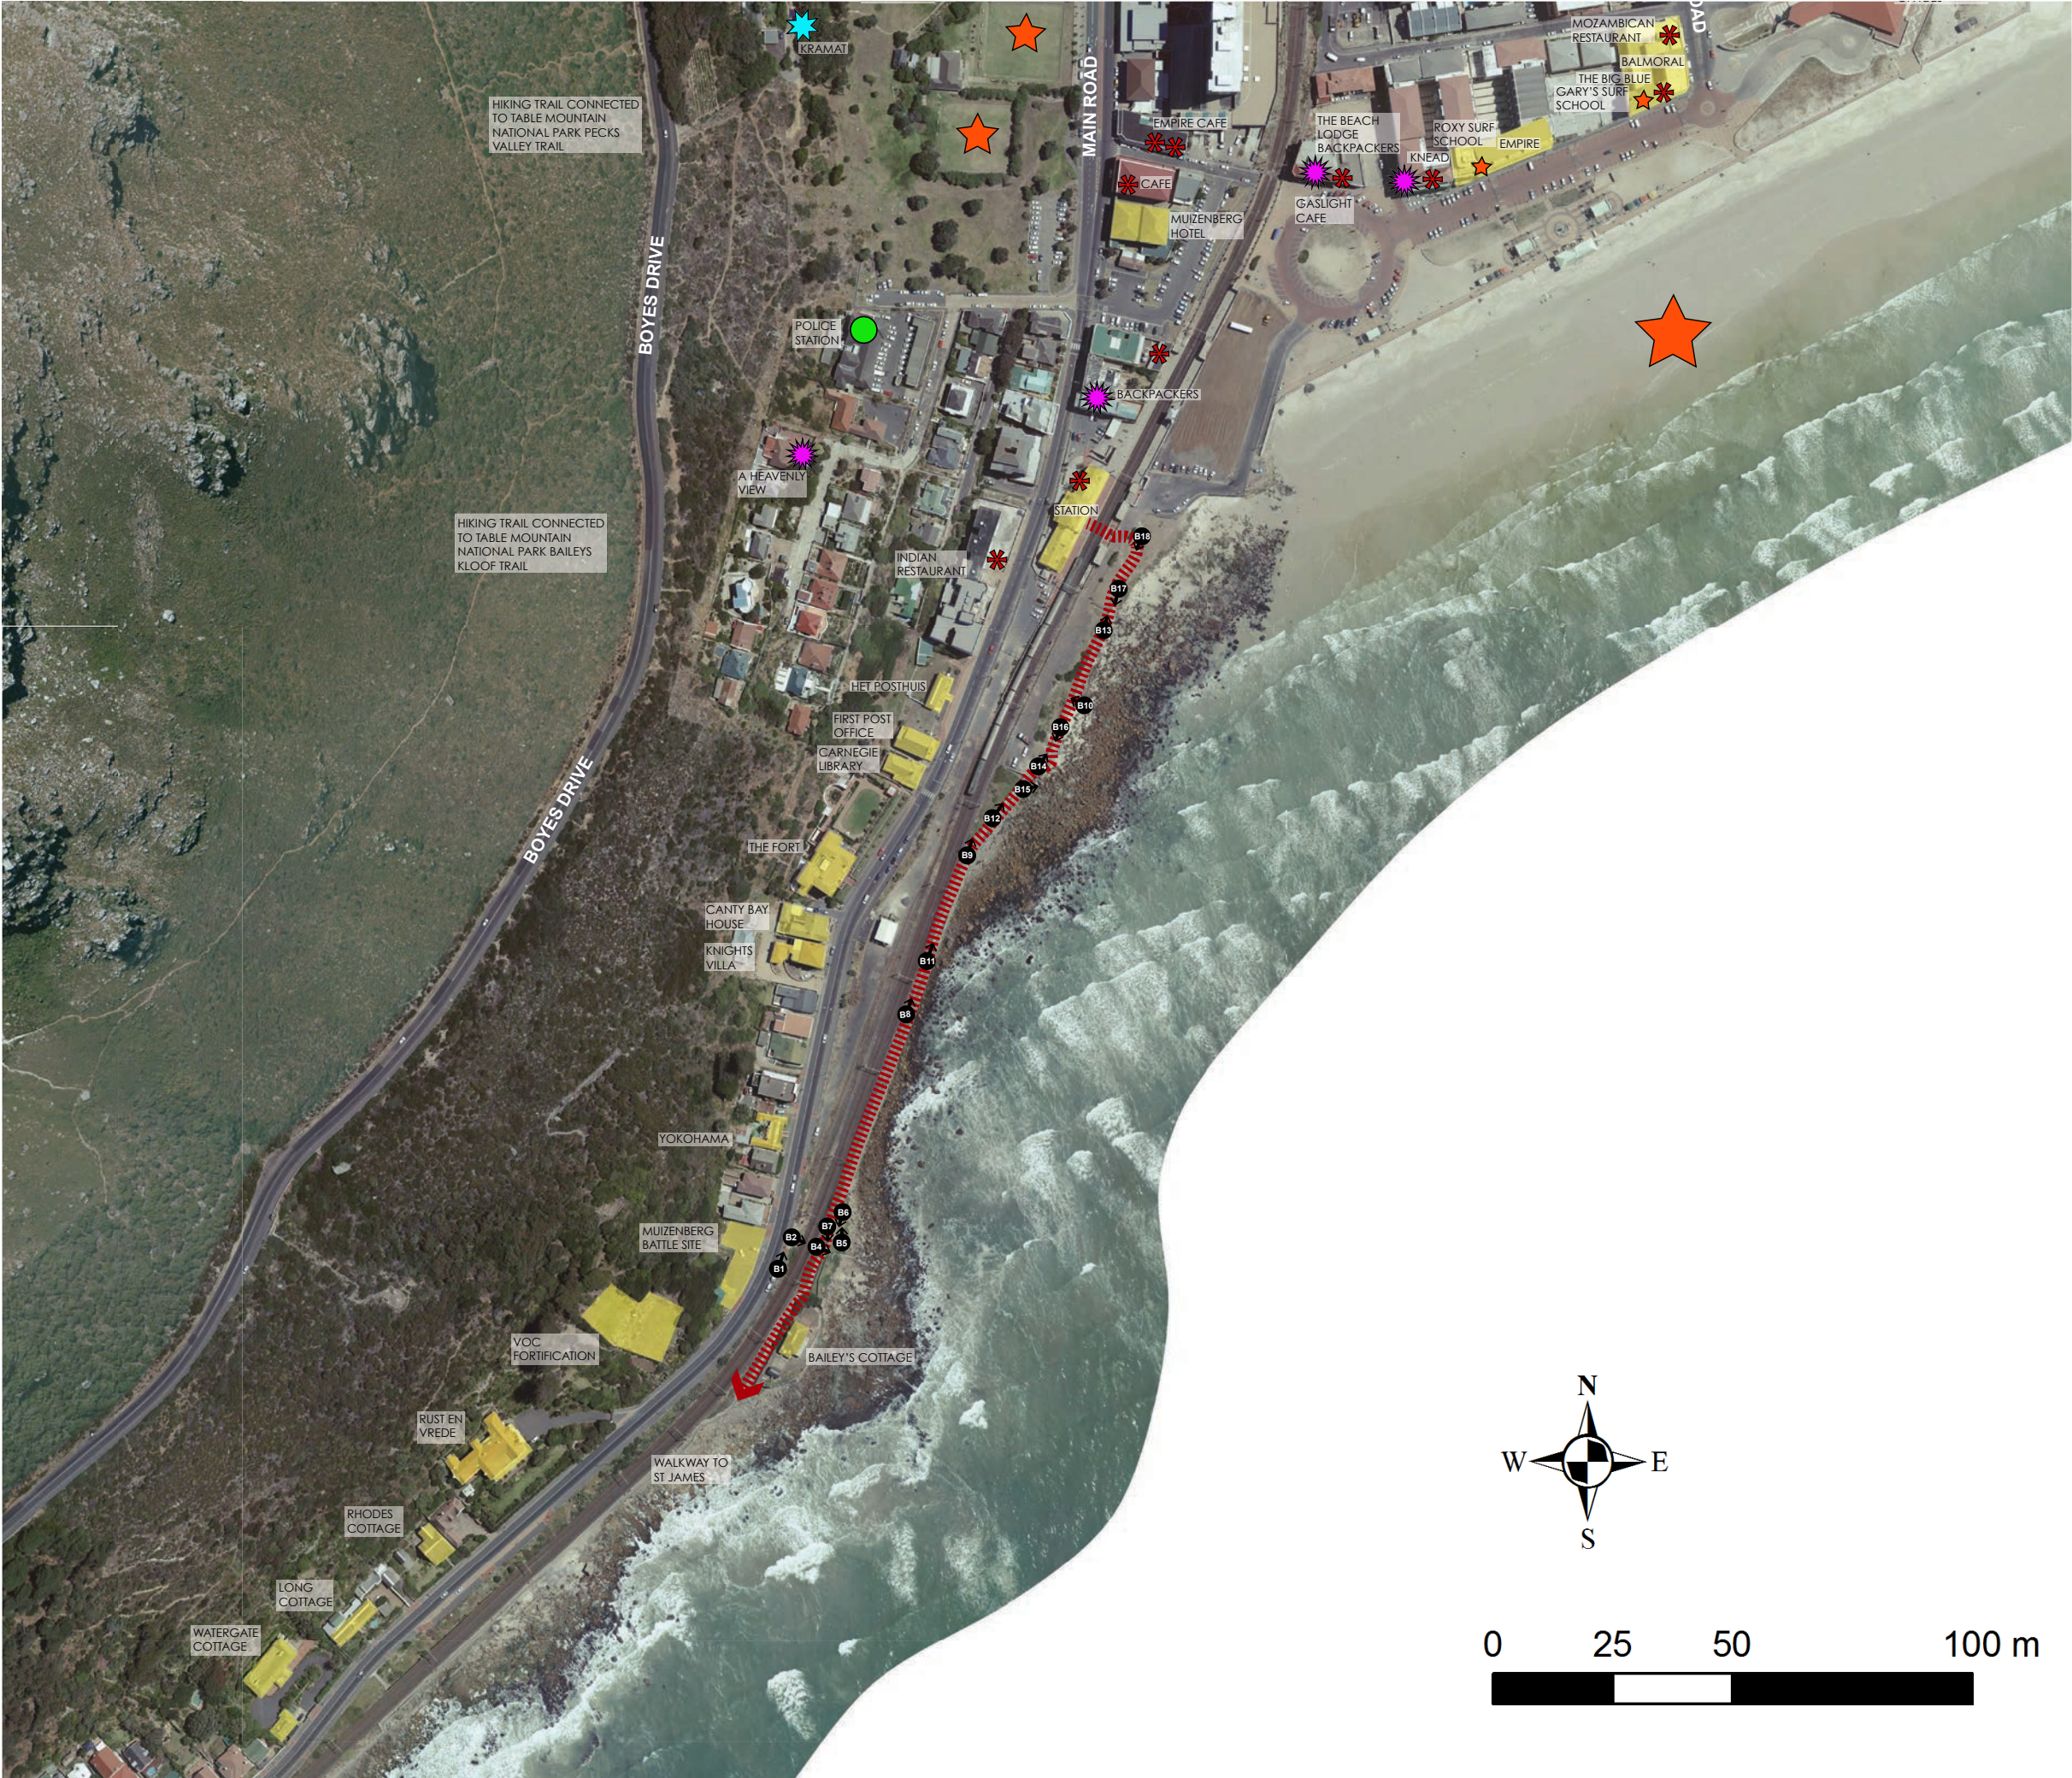
ROUTE B_STATION TO ST JAMES (COASTAL WALKWAY)

The coastal walkway starts at the Muizenberg Station and extends towards St James. The walkway is in good condition with many opportunities for seating along the walkway. The benches along the walkway are not in good condition and many need to be replaced or fixed. The steel balustrade needs to be repaired in certain places. The concrete walkway is in good condition and only needs minimal repair in some places.

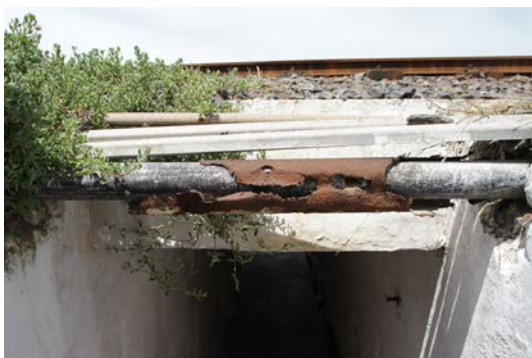
3. Asbestos piping and rusted piping exposed above subway entrance

- 48. Exposed asbestos piping to be repaired
- 49. Entrance to Subway (Beach Road)
- 50. Entrance to Subway (Sea side)
- 51. Proposed signage
- 52. Proposed signage

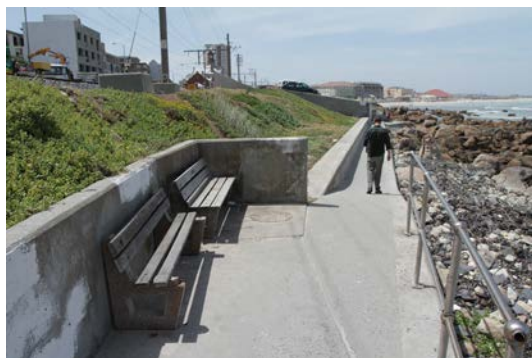
9. Good position for seating area but benches are broken and in need of repair

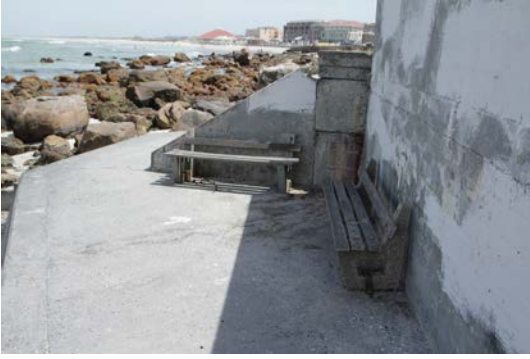
14. Broken benches along the walkway need to be repaired. Wall facing the sea has been painted white to hide graffiti, a more neutral grey colour could be used.

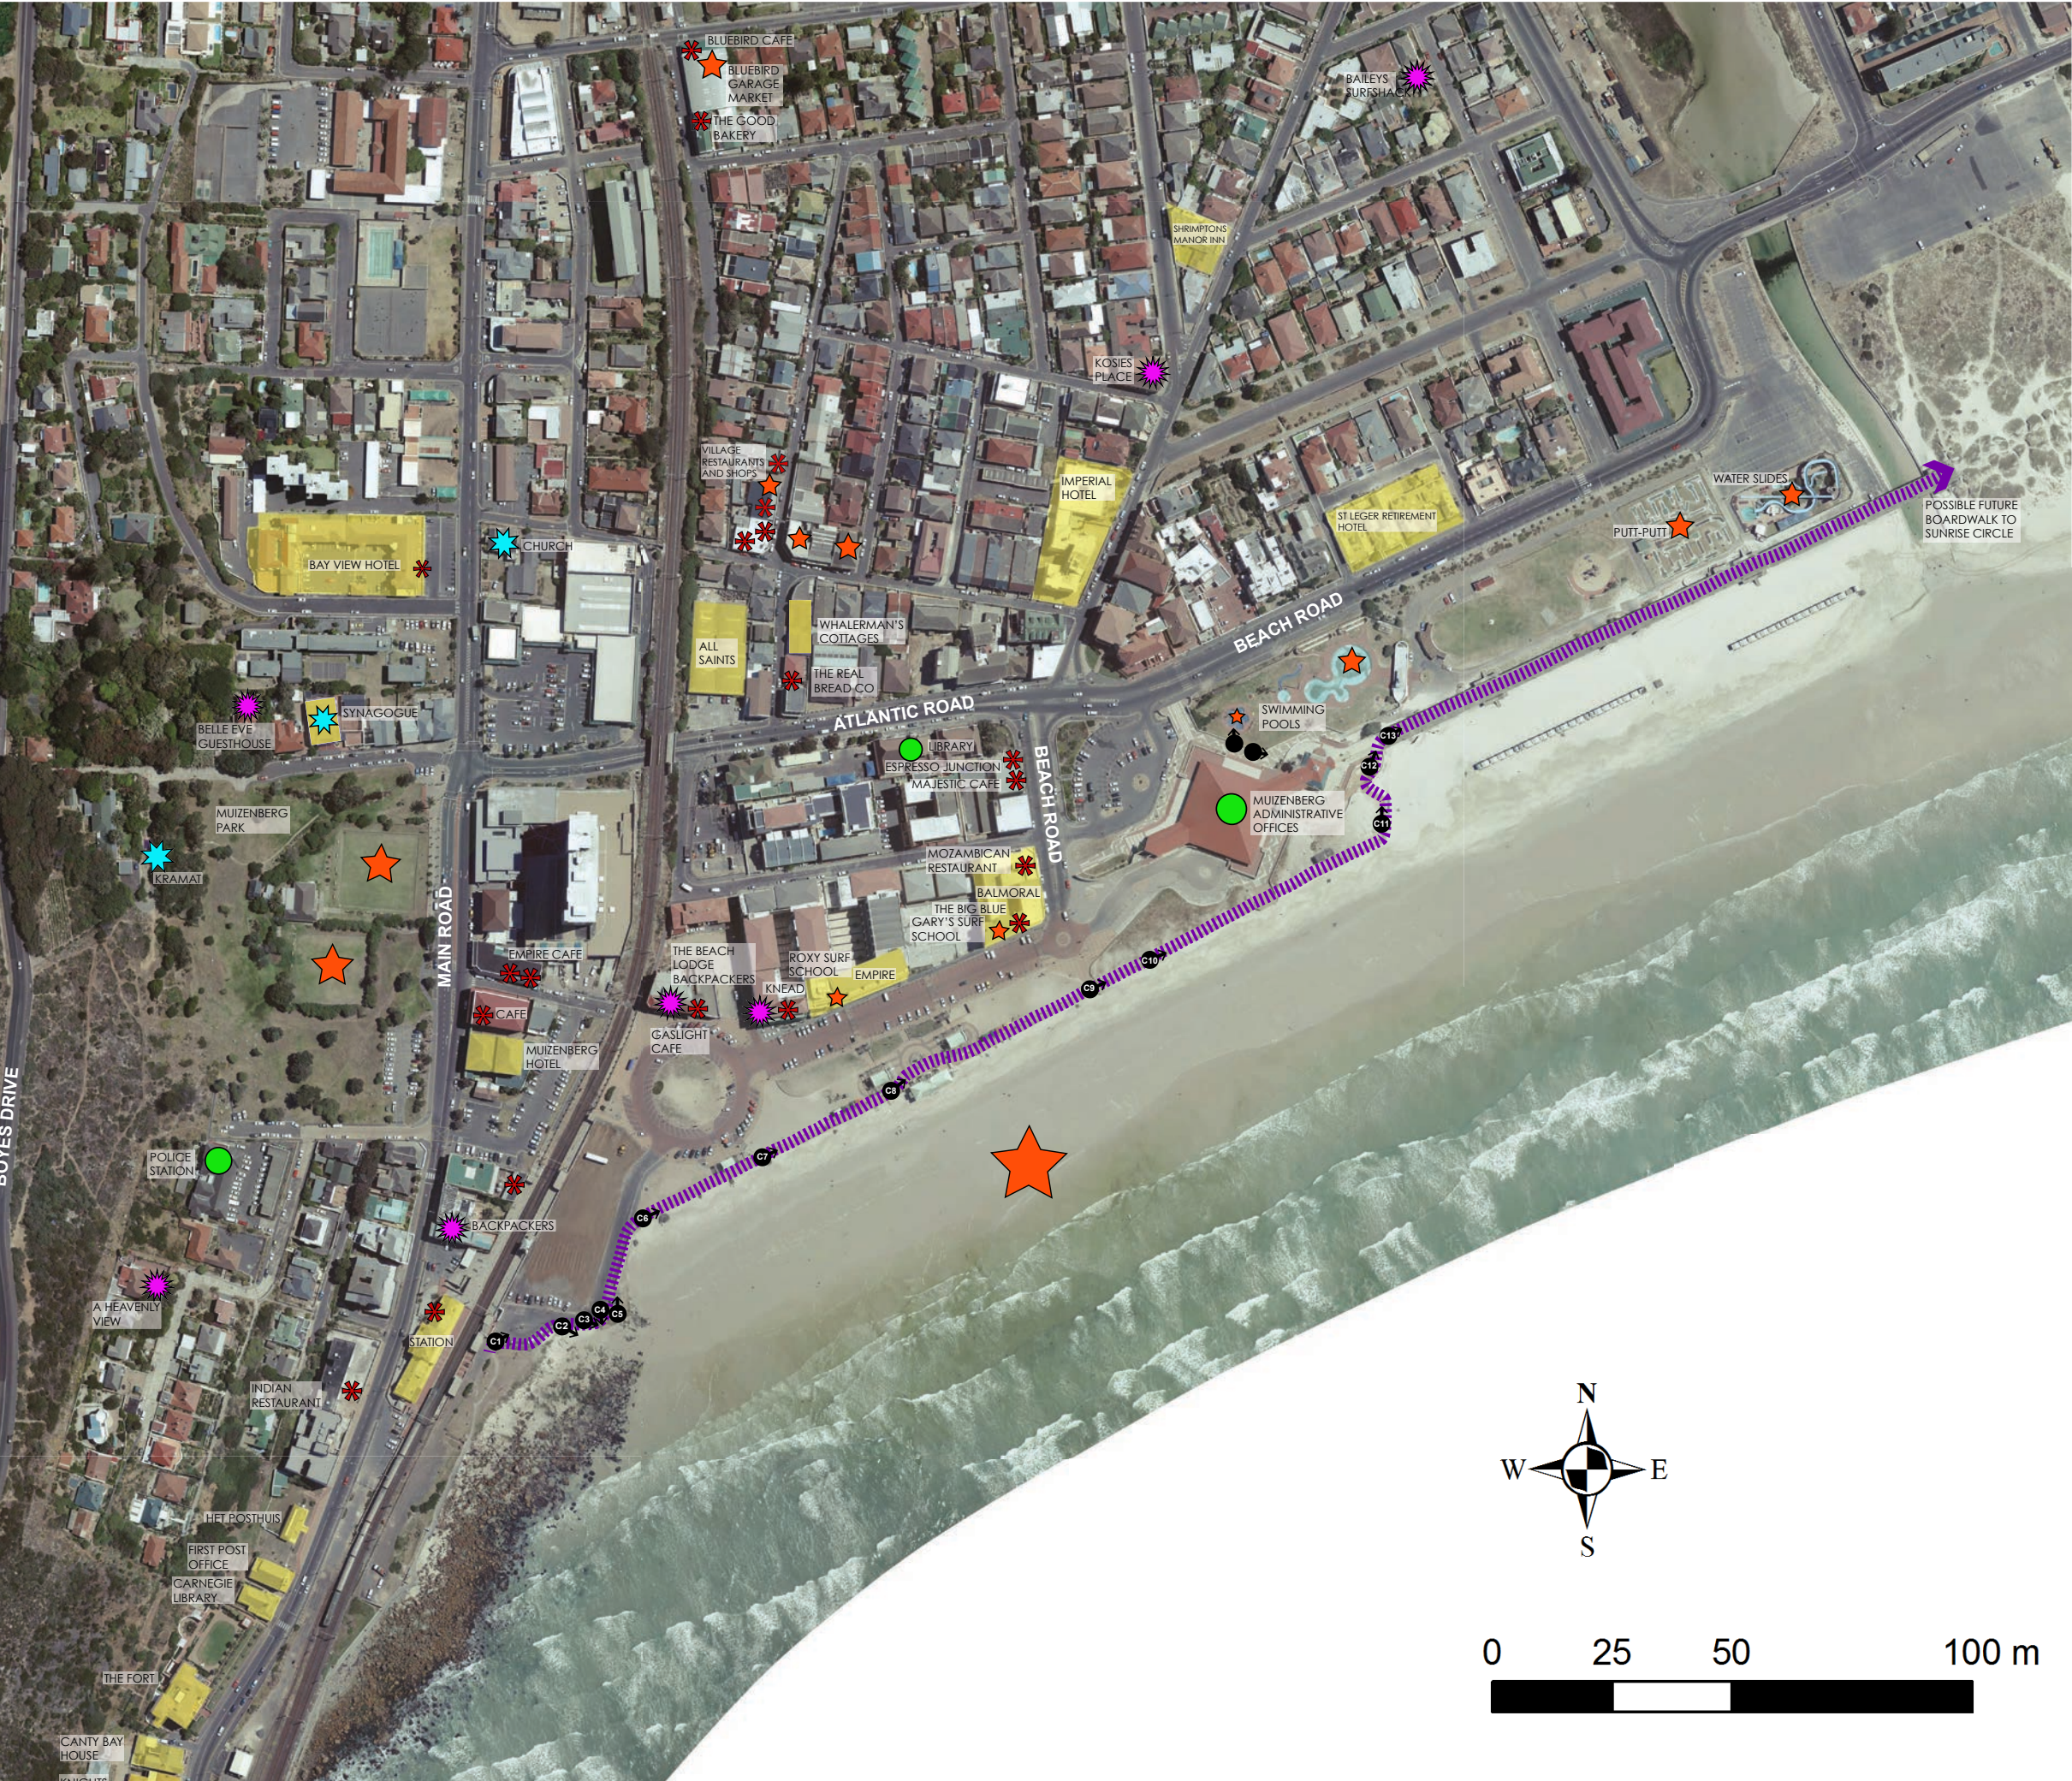
ROUTE C_STATION TO MUIZENBERG PAVILION (ON THE BEACH)

The walk starts at Muizenberg Station and extends eastward along the beach towards the Muizenberg Pavilion and links to the proposed boardwalk along the dunes.

The paved walkway is uncluttered and in good condition and contains timber seats creatively integrated with the retaining wall.

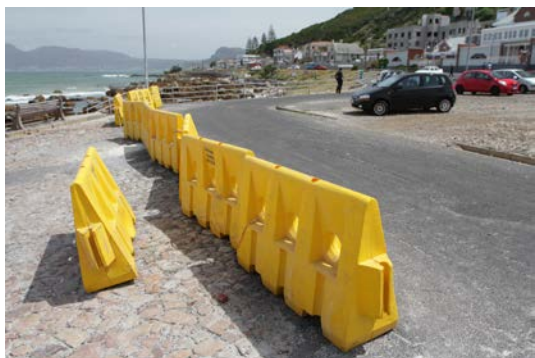
3. Temporary yellow safety railings to be removed and replaced with bollards

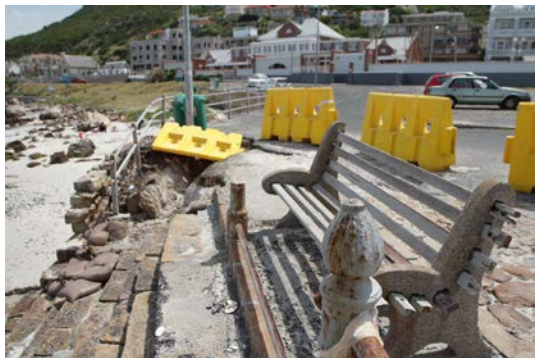
4. Storm damaged and eroded area is a hazard, paving to be repaired and the railing and bollards are to be reinstated

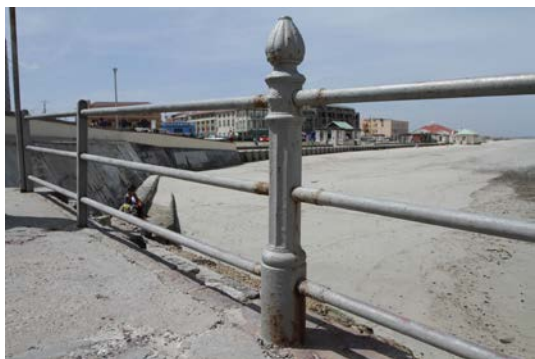
5. Historic post and rail repaired with modern railing, a sign of disrespect to the historic elements

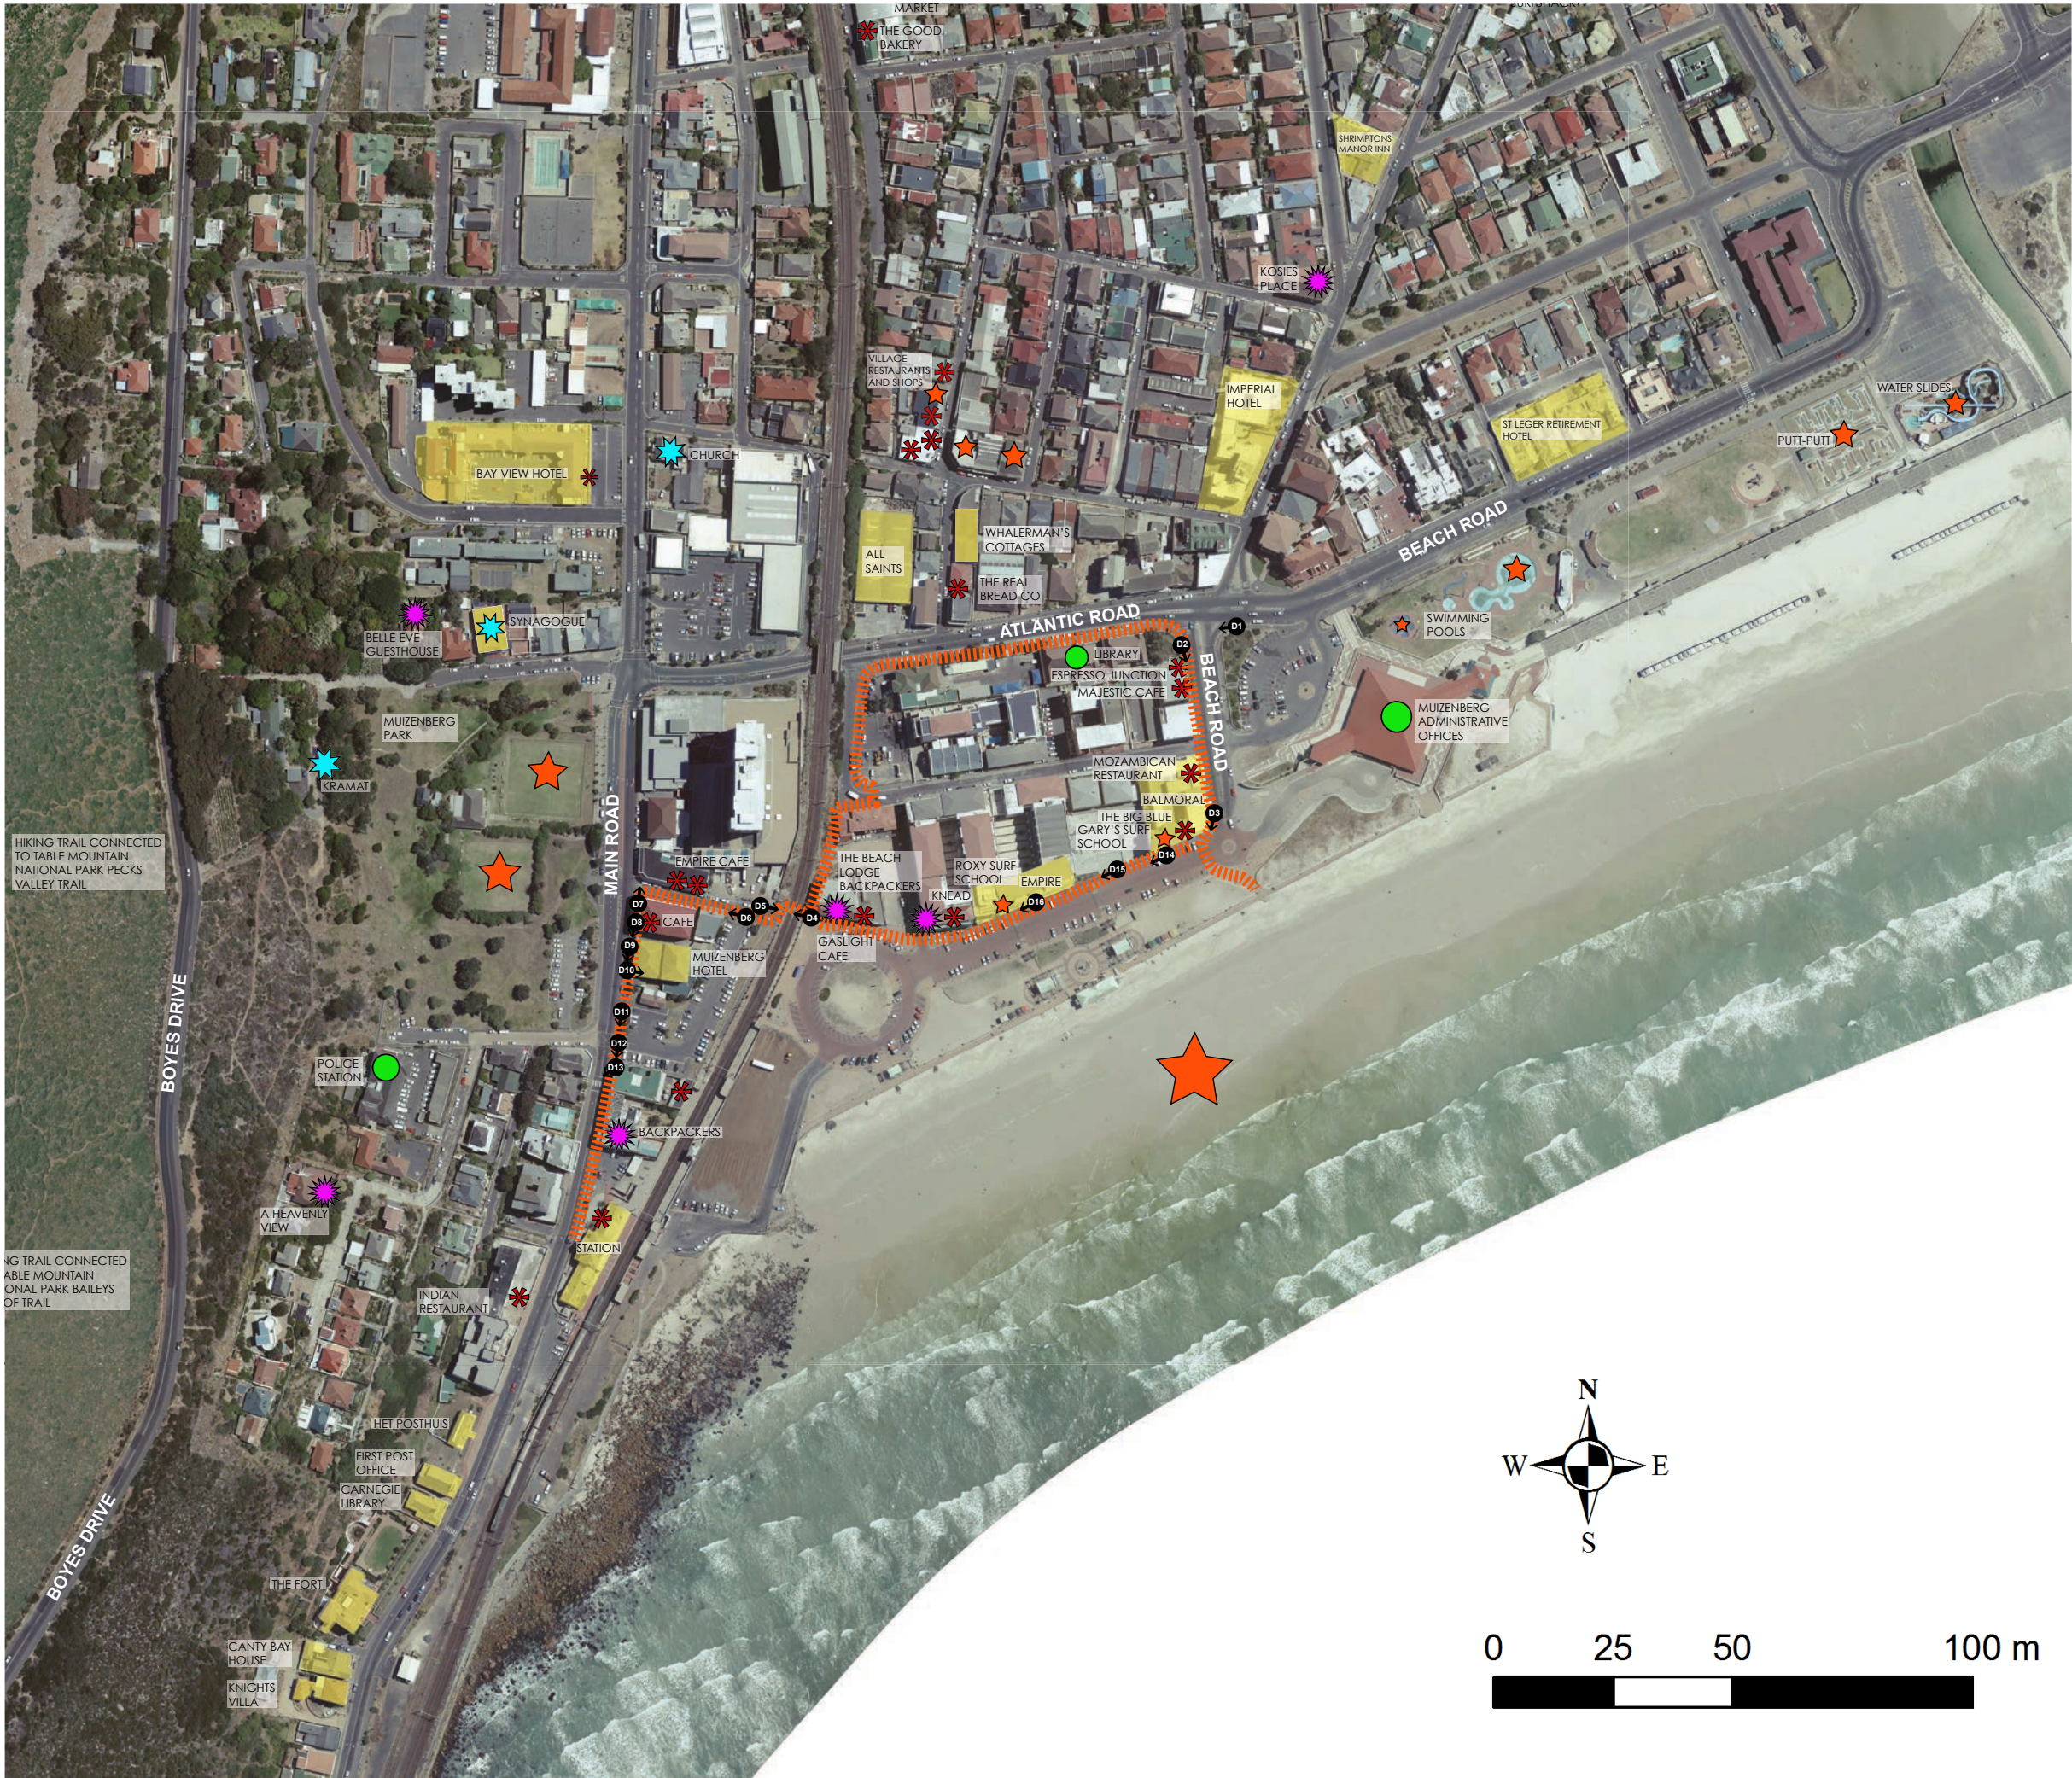
ROUTE D_STATION TO THE VILLAGE AND BACK TO THE BEACH

The route starts at the Muizenberg Station and extends down Main Road towards the village and back towards the beach. The route includes restaurants and many recreational activities. The route extends across the existing railway crossing which is to be retained but accomodate for universal access.

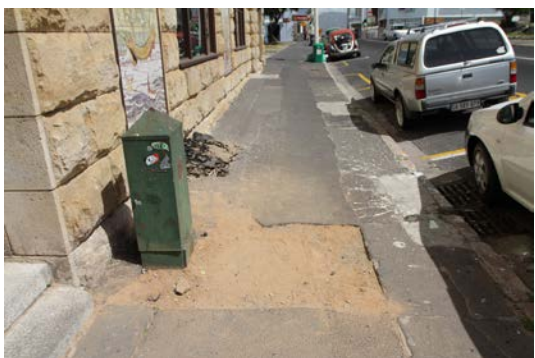
9. Asphalt surfacing is broken and in need of repair

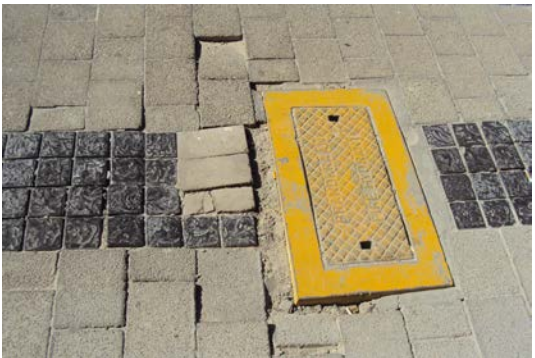
15. Degraded exposed aggregate and cobble paving

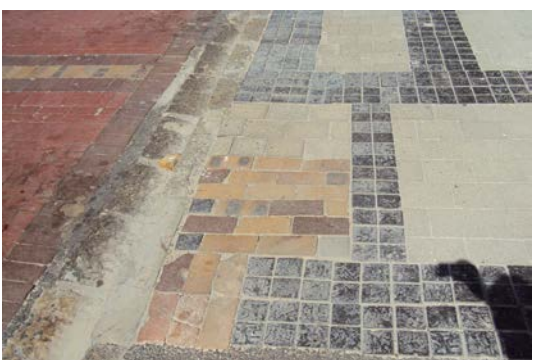
16. Repairs to the sidewalk are made with different paving materials to the original.

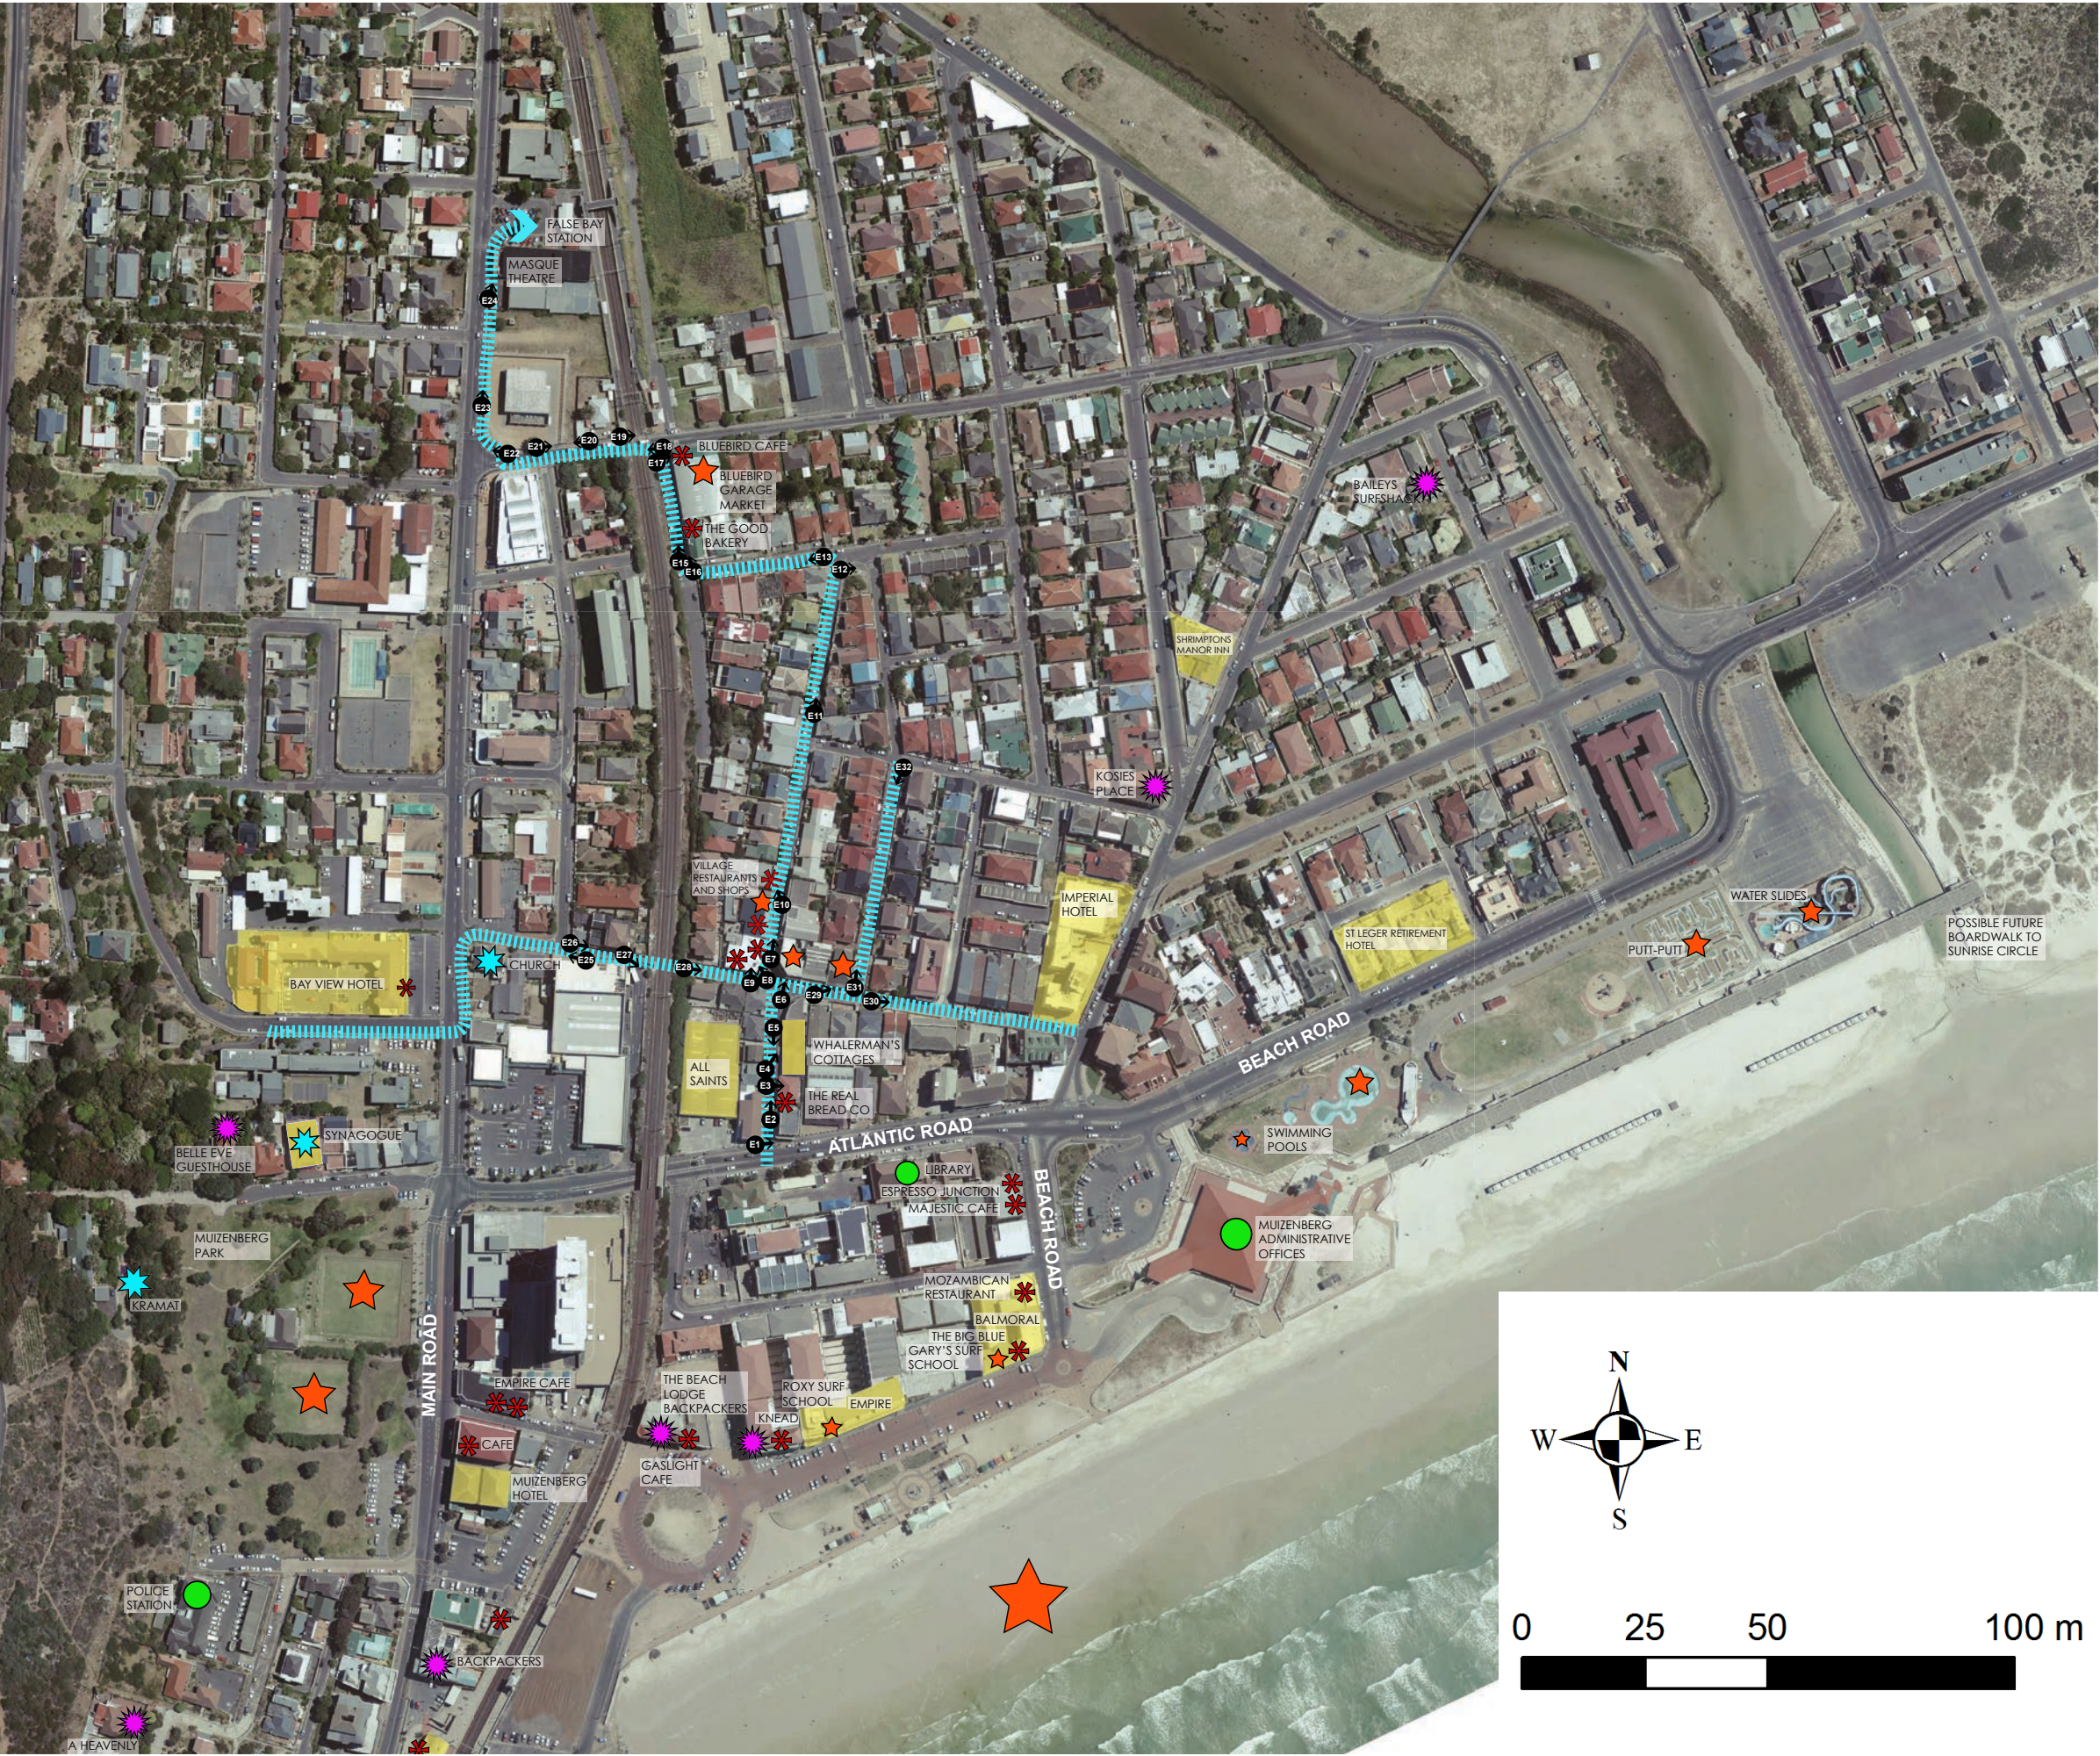
ROUTE E_VILLAGE WALK

The village walk includes Palmyra Road, Kilarney Road, Church Road and Hanson Road. The walk extends to False Bay Station. In general there are little or no sidewalks throughout Muizenberg. In Palmyra and Killarney Road there sidewalks are congested due to cars parking along and on the sidewalk. Pedestrians currently walk in the street. The route extends through the village retail area and pass many restaurants in Palmyra Road.

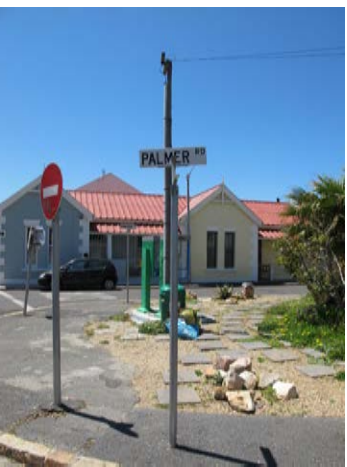
12. Asphalt is broken and patchy and in need of repair. Sign posts are placed in the middle of the sidewalks limiting universal access

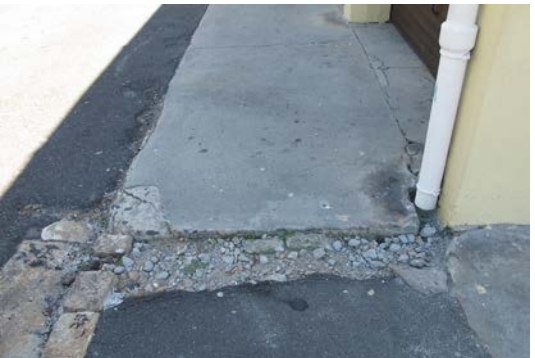
16. Broken asphalt to be repaired

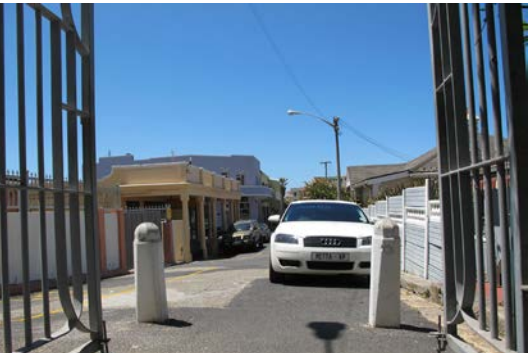
28. Asphalt is patchy and broken at village side of the subway
