MUIZENBERG PEDESTRIAN TOURISM ROUTES

CONTENTS PAGE

METHODOLOGY

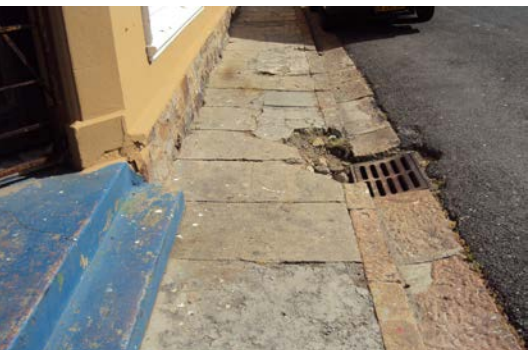
31. Hanson Street - the concrete sidewalks are degraded and need to be repaired.

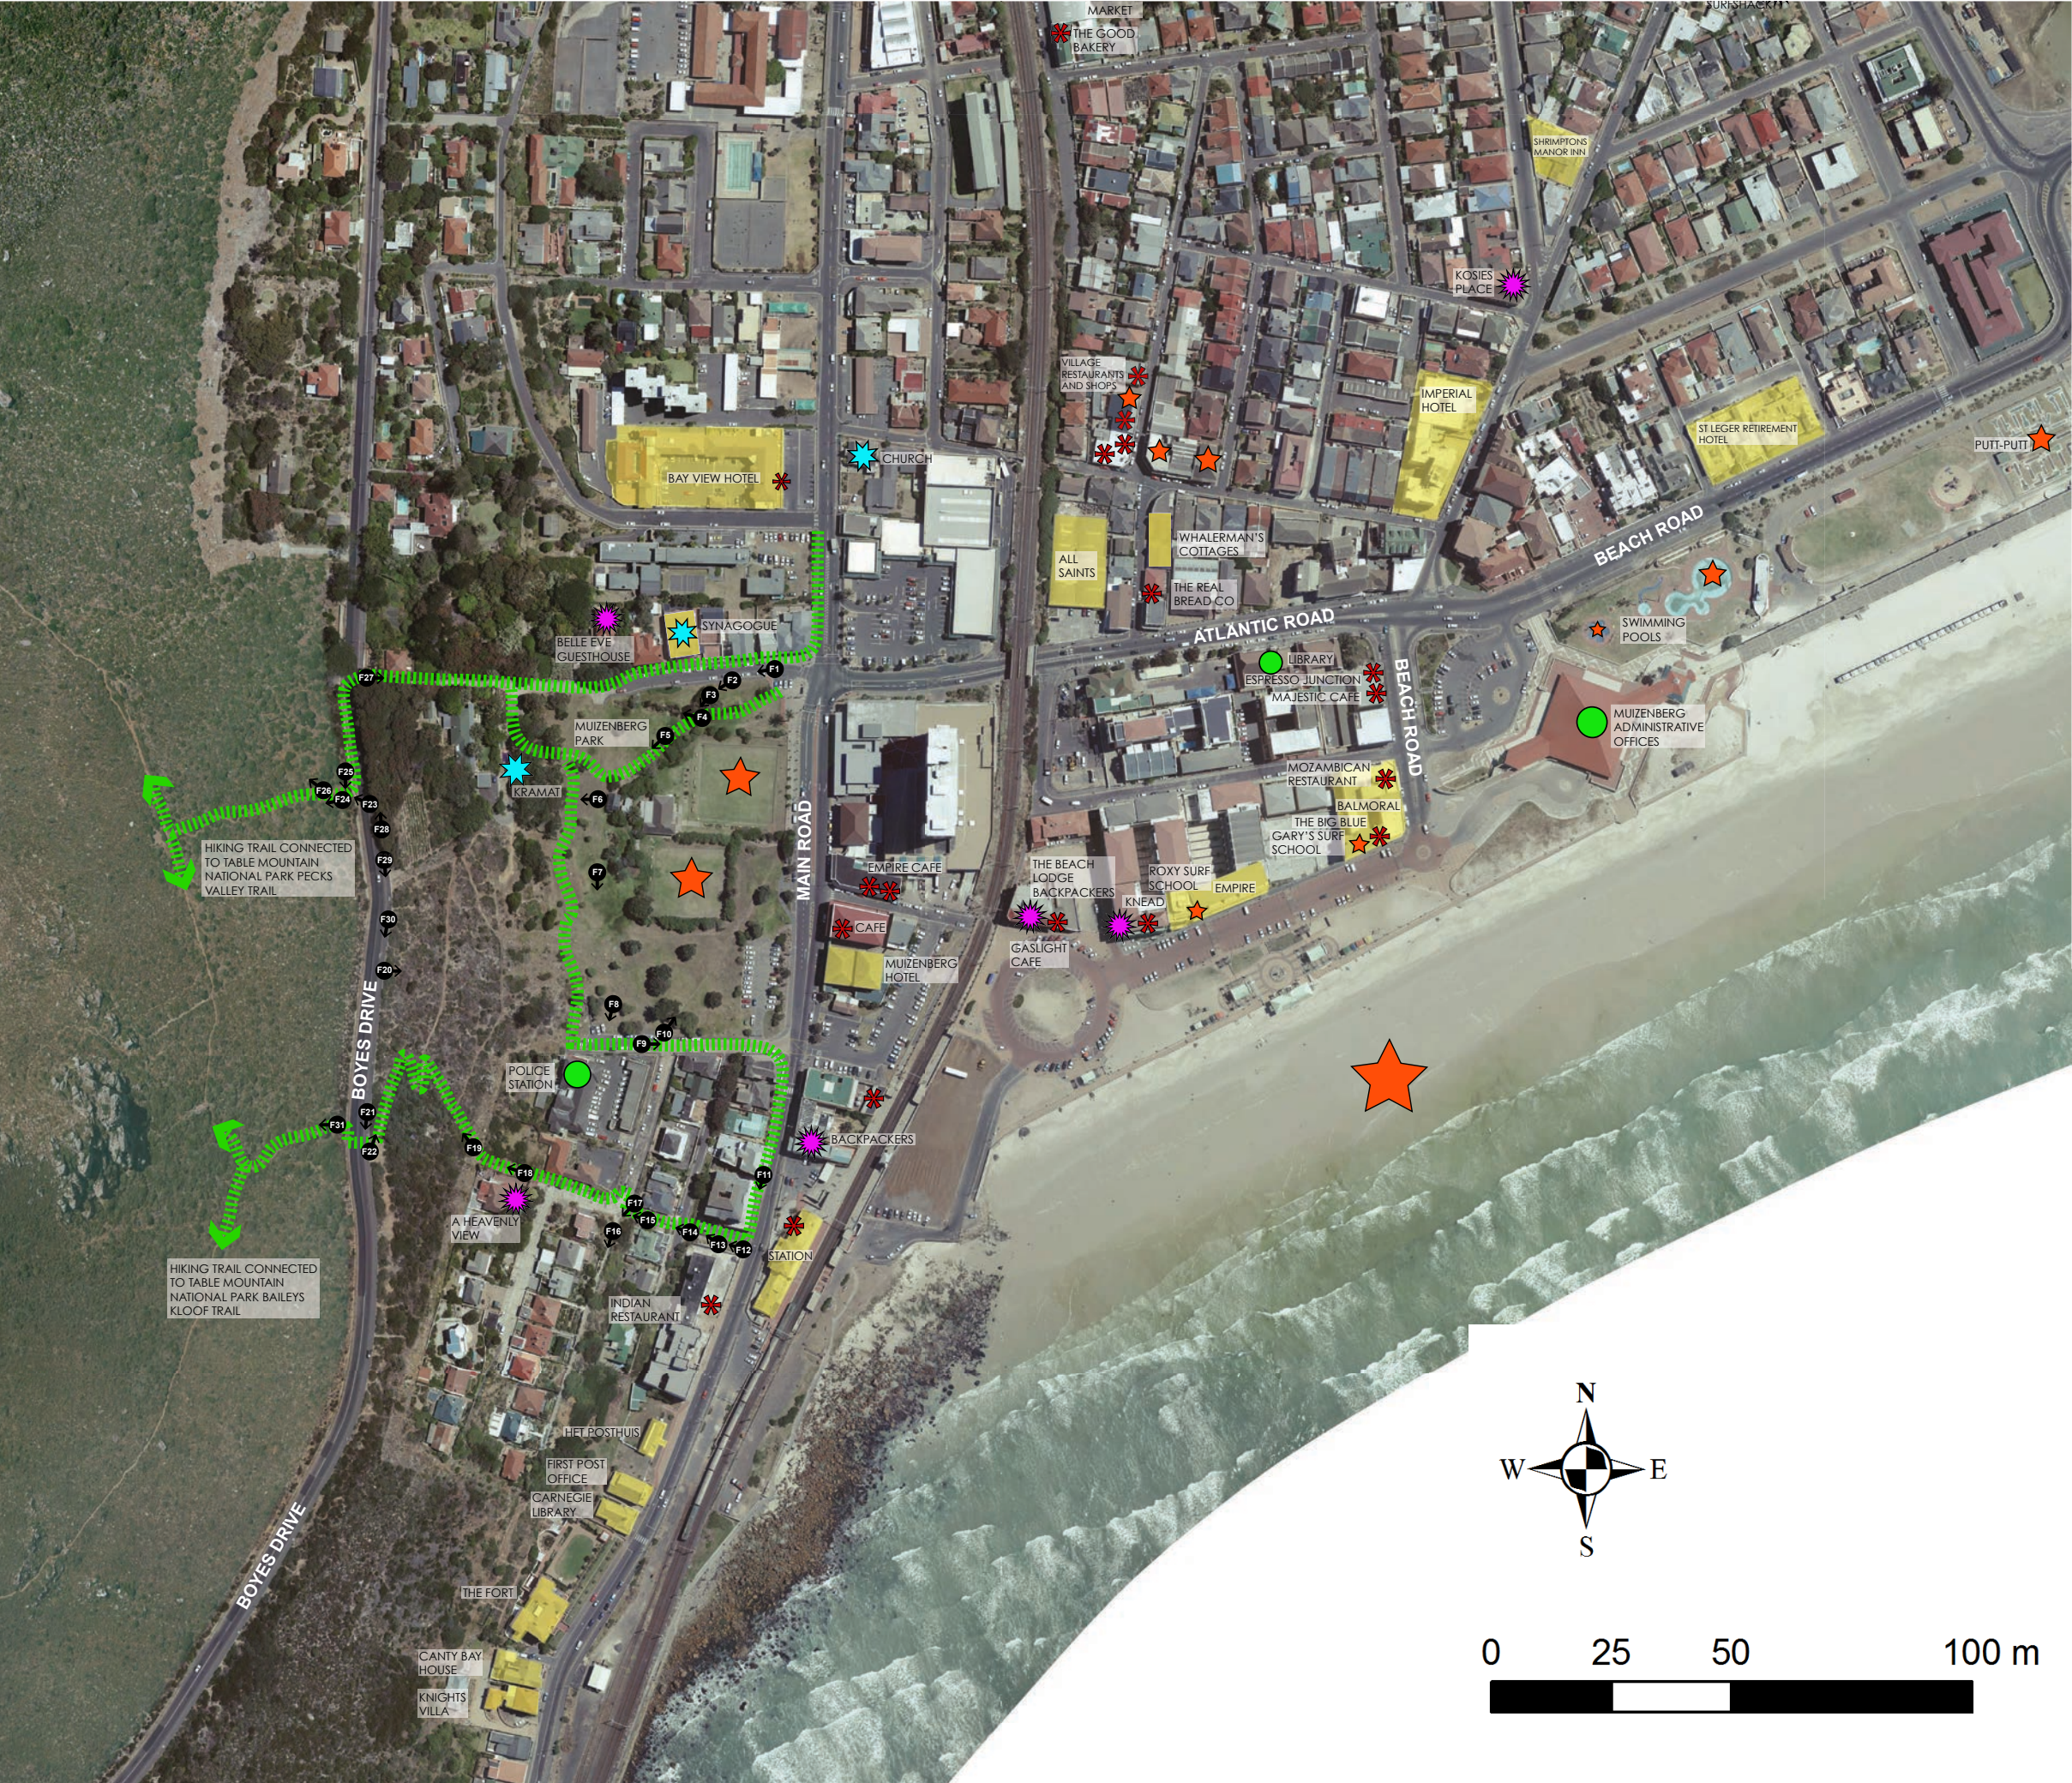
ROUTE F_PARK AND TRAILS

The route extends from Main Road through Muizenberg Park, up towards Boyes Drive linking to the Table Mountain National Park Hiking Trails. Muizenberg Park is well maintained and in good condition. The sidewalk along Boyes Drive is in need of repair as there are large cracks in places. There are seating bollards placed in the middle of the walkway which does not permit universal access. These seating bollards and bins should be located near significant entrance points. The hiking trail leading up to Boyes Drive is overgrown and there is no signage indicating that the route extends towards the Table Mountain National Park Hiking Trail. The railway sleepers need to be reset and secured.

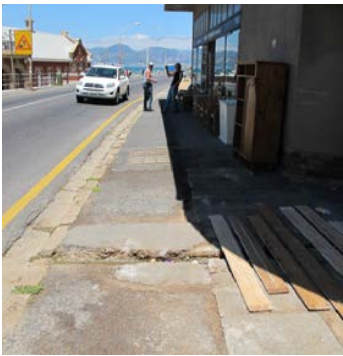
11. Drainage channel in asphalt sidewalk is in need of repair. Water is flooding the pedestrian route. Surrounding asphalt is patchy and in need of repair.

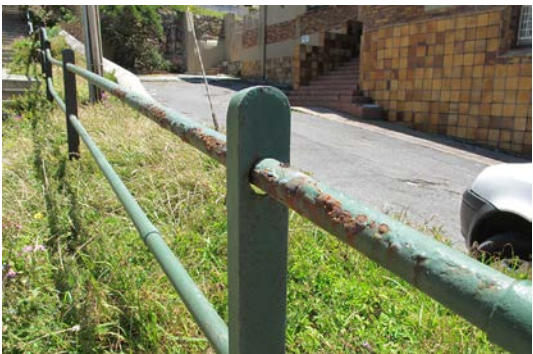
13. Rusted railings need to be replaced.

- 139. Replace grating
- 140. Replace rusted railing
- 141. Proposed signage
- 142. Repair disintegrated concrete coping on steps
- 143. Railing to be repaired (start)

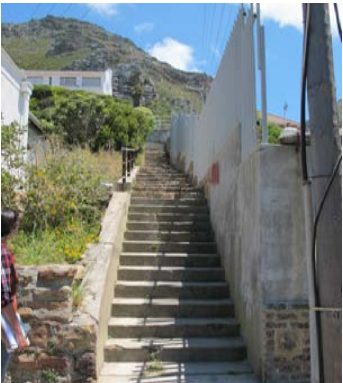
15. Concrete finish on top of brick paving is disintegrating on the stairway and in need of repair.

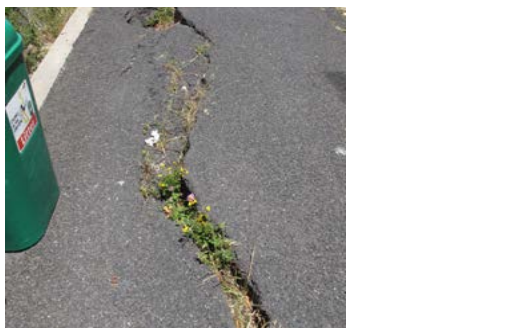
30. Asphalt sidewalk along Boyes Drives is in need of repair.
