# KNOW YOUR COAST, 2021

Key findings from over 10 000 sample bacterial tests at 99 sites along 307 km of coastline.

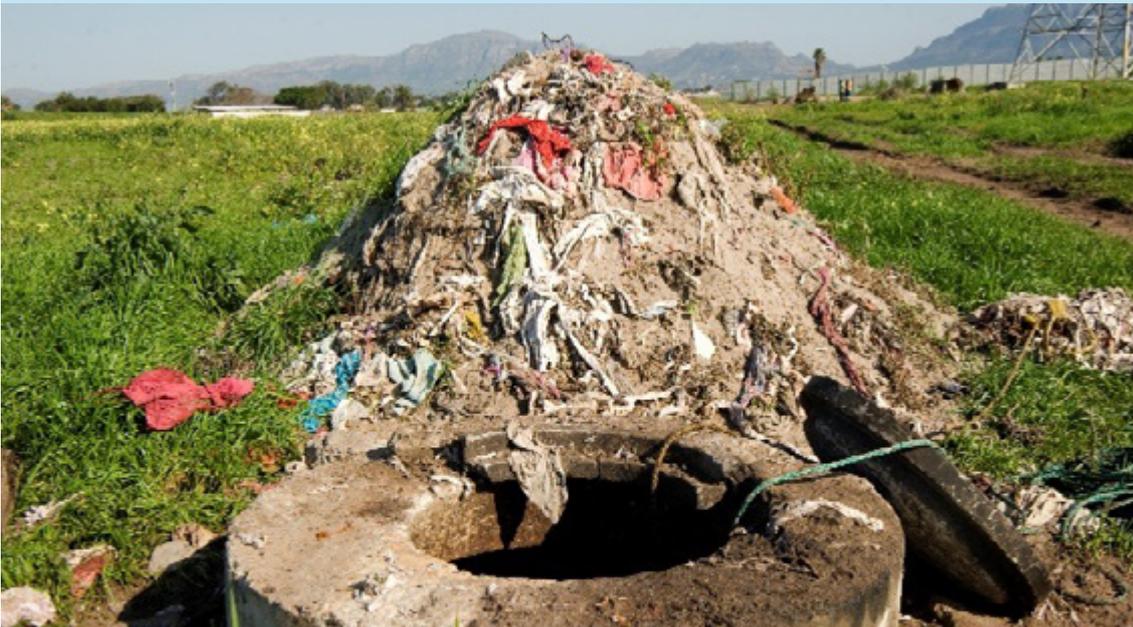
**FIGURE 1: FOREIGN MATERIALS REMOVED FROM THE CITY'S SEWER SYSTEM**

While blockages from misuse are a major issue, there are also cases of sand ingress into sewer lines, leading to blockages and leaking, which require ongoing maintenance (more information on this can be found on pg. 30 of this report). There are also cases of damaged or collapsed pipes causing leakages into the environment. Investment into upgrades and response efficiency to address these challenges are provided in this report.

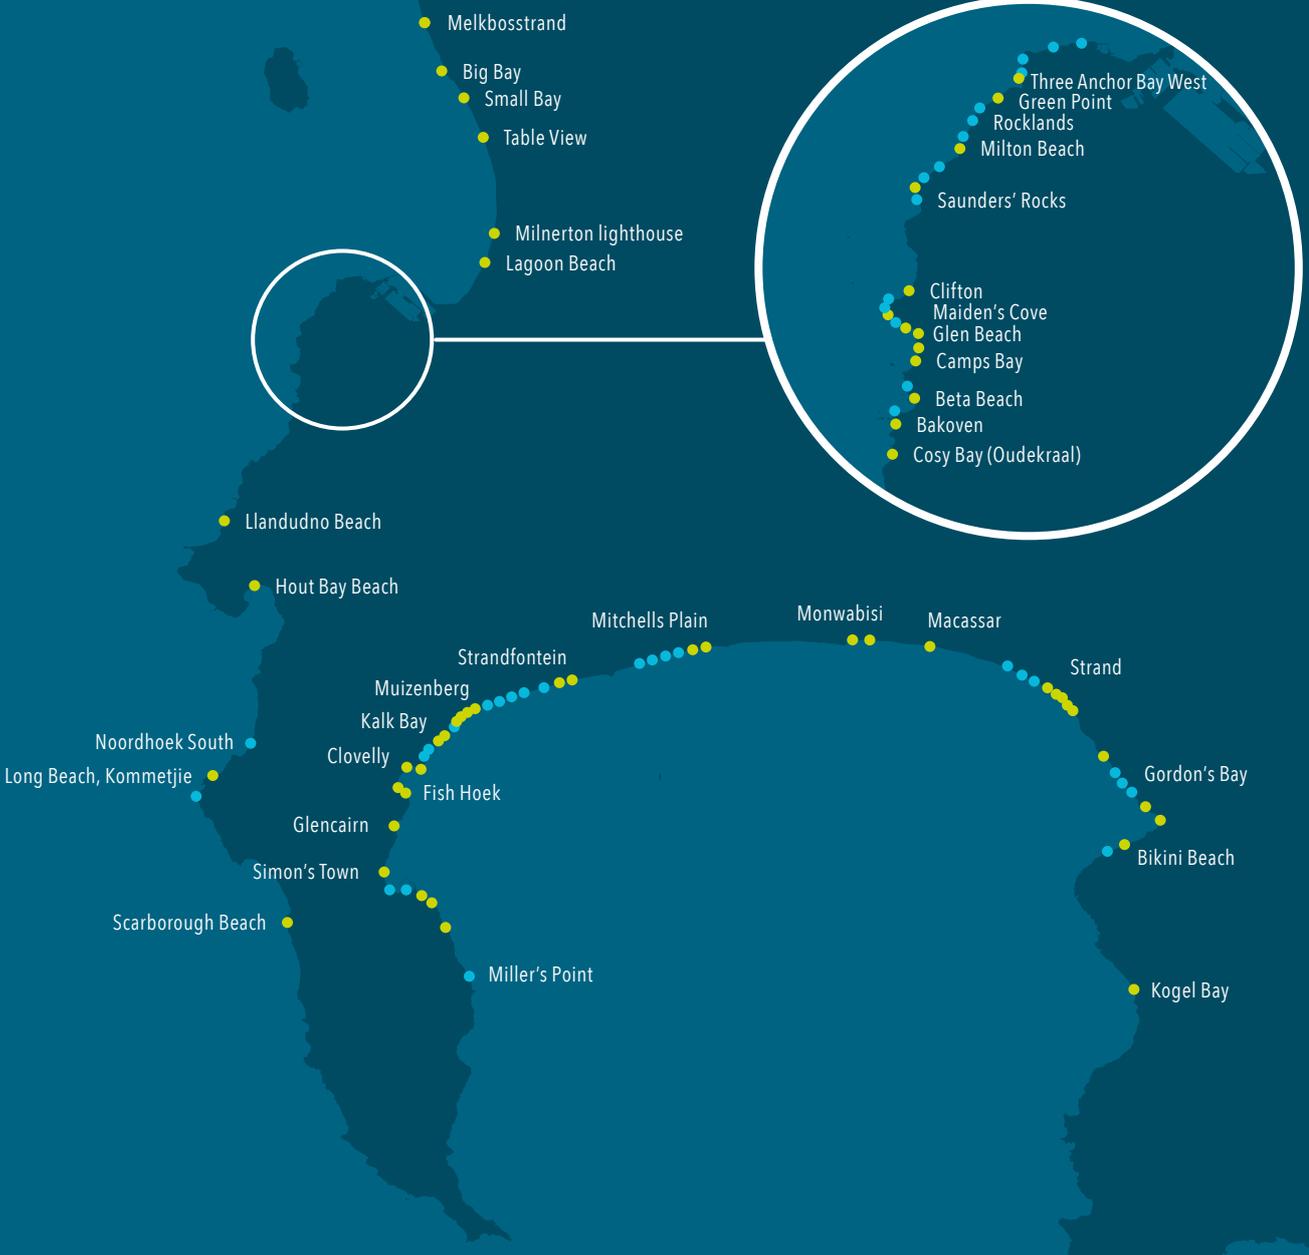
**FIGURE 2: SAMPLING SITE LOCATIONS**

In 2020, the City added 11 additional sites to its 88 coastal quality-sampling points, taking the total points monitored twice per month to 99 sites (figure 2). These new sites were added specifically to advance our knowledge at certain locations in respect of the drivers behind poor coastal water quality. This, in turn, will aid the City in formulating appropriate management interventions towards improving coastal water quality for these areas. The detail of these new sample sites, and the rationale for choosing these sites, may be found on pg. 8 of the [\*KYC, 2020\*](#) report.

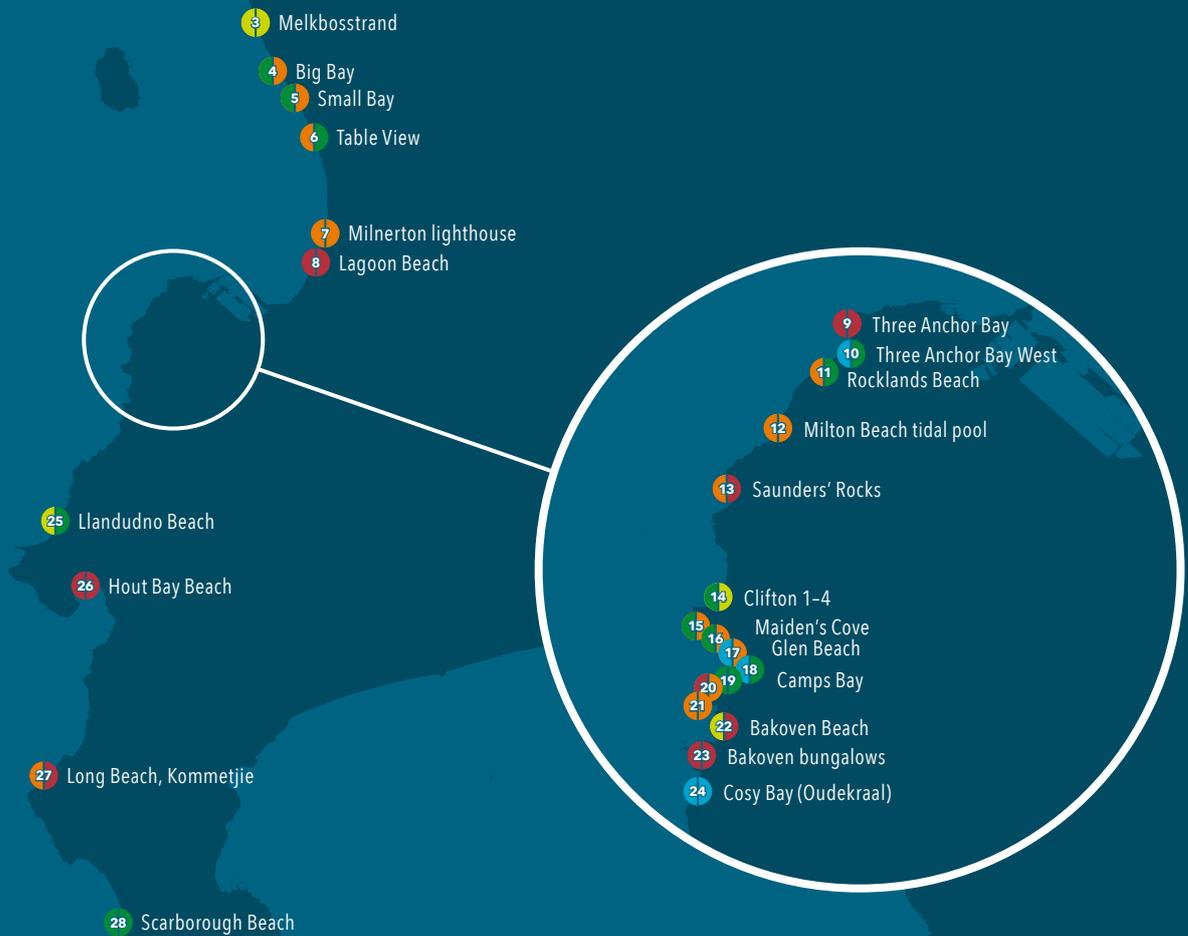
**FIGURE 3: WATER-QUALITY RATINGS FOR RECREATIONAL NODES ALONG THE ATLANTIC COAST**

- Water quality at 20 (71%) of the recreational nodes (figure 4A) met the minimum requirement for recreational use in 2021 (eight were rated 'excellent', two 'good' and ten 'sufficient').
- Seven (25%) of the recreational nodes were rated as 'poor'. These were Lagoon Beach, Three Anchor Bay, Saunders' Rocks tidal pool, Bakoven bungalows, Bakoven Beach, Hout Bay Beach and Long Beach, Kommetjie.
- Cosy Bay (Oudekraal) had insufficient data to complete an accurate analysis.

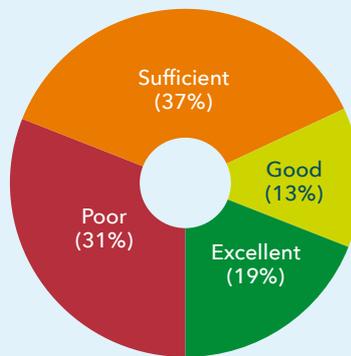
**FIGURE 4A: DISTRIBUTION OF 2020 COASTAL WATER-QUALITY RATINGS, ATLANTIC COAST**

At the coastal monitoring points, 31% of the results from the monitoring sites were classified as 'poor' in 2020. In 2021, 12% were rated as 'poor'.

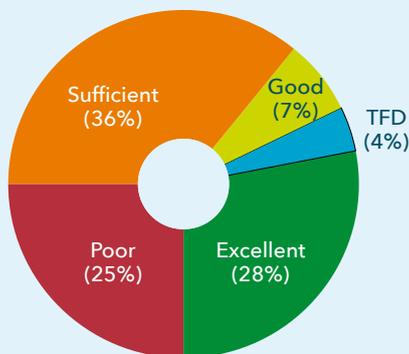
**FIGURE 4B: DISTRIBUTION OF 2021 COASTAL WATER-QUALITY RATINGS, ATLANTIC COAST**

- Water quality at 15 (88%) of the monitoring points along the Atlantic coast (figure 4B) met the minimum requirement for recreational use in 2021 (six were rated 'excellent' and nine 'sufficient').
- At two (12%) of these sites, water quality was rated as 'poor'. These were the sampling sites located at Park Road (Green Point) and Saunders' Rocks.

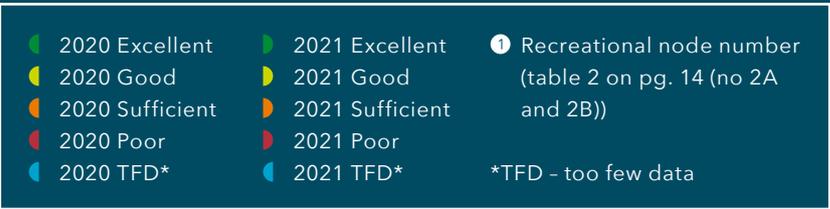
**FIGURE 5: WATER-QUALITY RATINGS FOR RECREATIONAL NODES ALONG THE FALSE BAY COAST**

Along the False Bay coast, water quality is now monitored at 33 recreational nodes and 21 coastal monitoring points (figure 2). Figure 5 presents the locations and overall categories for both recreational nodes and monitoring points for 2020 and 2021, respectively. Tables 5 and 6 provide an overview of annual water-quality ratings at these sites over a five-year period (i.e. 2017-2021). In this section, the results of 2021 are reported first, followed by a comparison of the results between 2021 and the preceding year (2020). Finally, it provides a closer look at a section of the coastline that proved to be an interesting case study.
