MUIZENBERG PEDESTRIAN TOURISM ROUTES

MUIZENBERG PEDESTRIAN  
TOURISM ROUTES  
November 2012

EARTHWORKS LANDSCAPE ARCHITECTS

ROUTE A\_HISTORICAL BUILDINGS AND BATTLE SITE ALONG BEACH ROAD

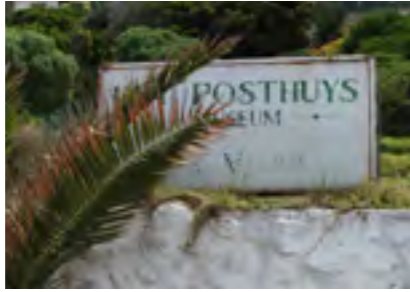
4. The sign in front of Het Posthuis is old and in need of some revitalisation. The signage is hidden behind a small palm.

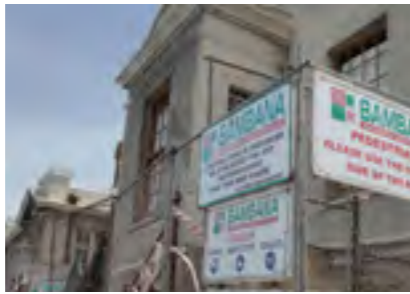
5. Construction is underway at the Historical Carnegie Library

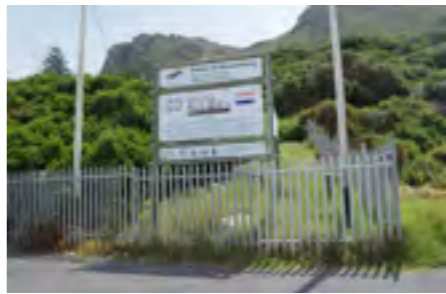
9. This parking lot should be redesigned to reflect the historical significance of the Battle of Muizenberg site.

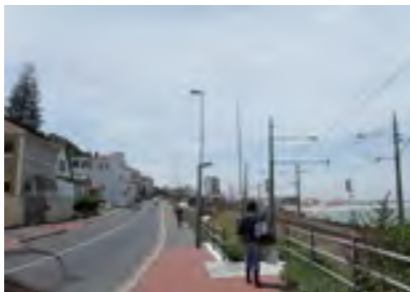
1. Slipway to the shoreline to be signposted

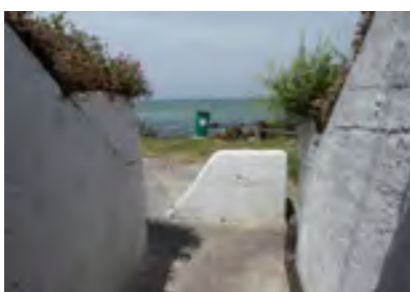
4. View through the subway towards the beach. Green council bin is poorly placed and spoils the framed view

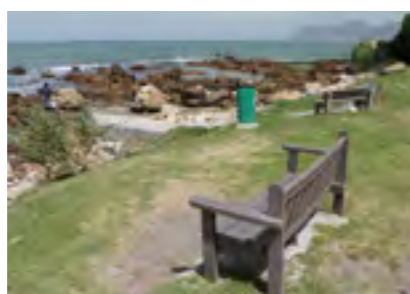
5. Good position of benches. Mix of bench designs, polywood bench next to exposed aggregate and timber bench, could be simplified.

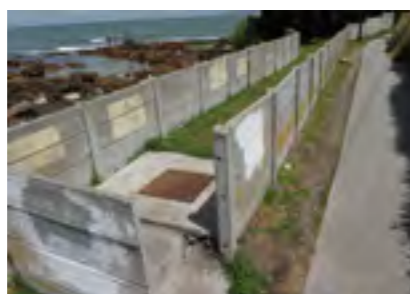
7. Vibacrete structure/ walls should be removed as it detracts from the natural environment

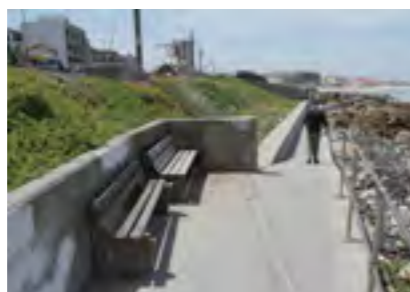
9. Good position for seating area but benches are broken and in need of repair

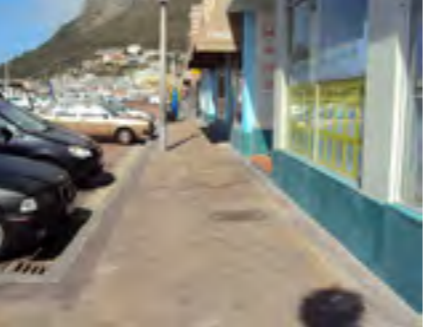
- 14. The paved walkway is a mix of different paving patterns and asphalt. The sidewalk is a comfortable width

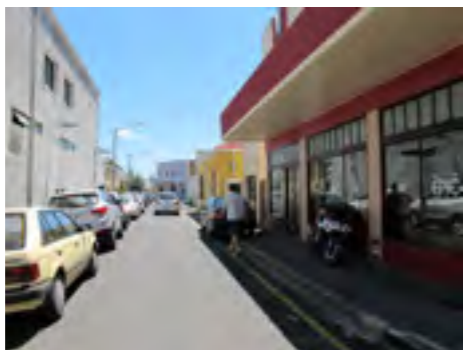
2. Killarney Road - parked cars dominate the sidewalks and pedestrians are forced to walk in the street

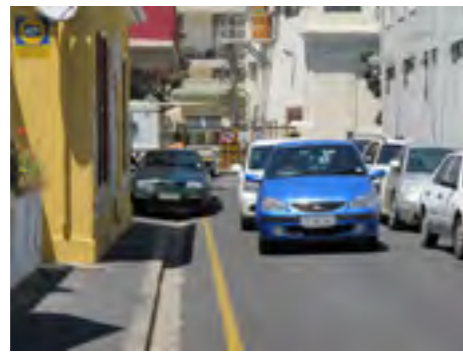
5. Narrow streets with limited sidewalks, this is uncomfortable for pedestrians but add to the village feel

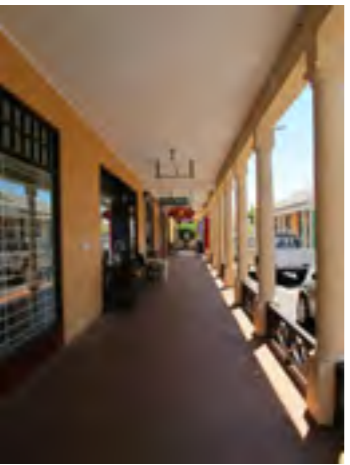
9. Covered sidewalk adjacent to restaurants and shops is in good condition and provides a comfortable pedestrian environment. The sidewalk is a comfortable width and allows the pedestrian to engage with the village shops and restaurants

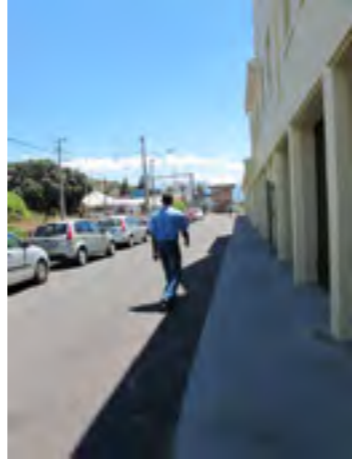
15. This area has no designated sidewalk area

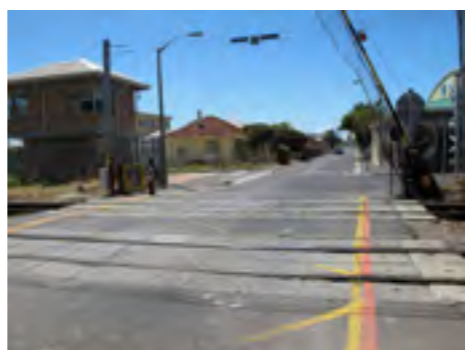
19. A pedestrian gate on one side indicates which side of the route to walk but a change in surface would be more legible to pedestrians

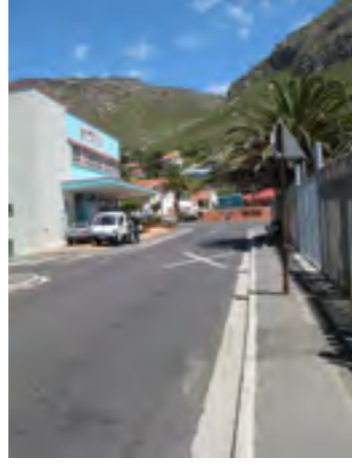
21. An old, empty sign placed in the middle of the sidewalk should be removed

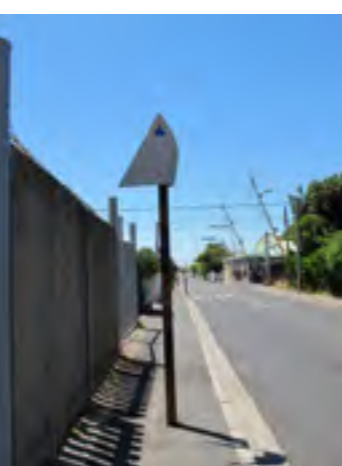
22. Large vehicular signboards dominate and clutter the pedestrian route

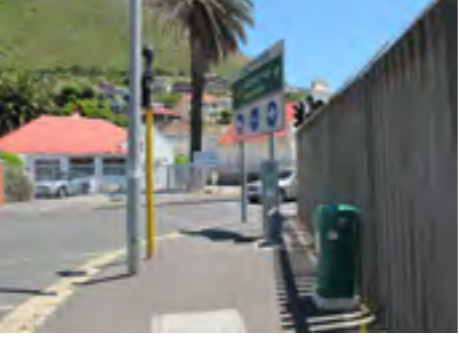
23. Narrow sidewalk along Main Road

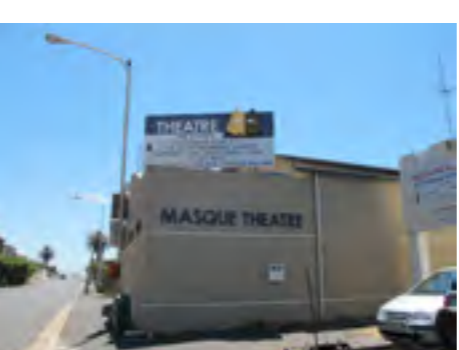
25. Signage should be placed along the main road indicating that there is pedestrian access via a subway to the village.

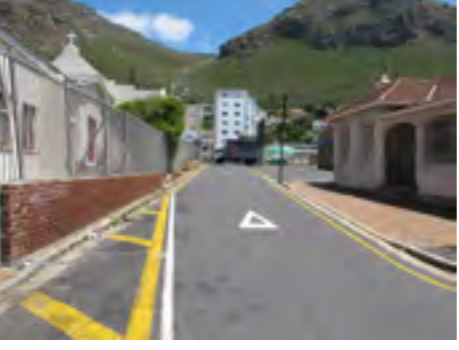
26. No designated pedestrian pavement. Delivery trucks offload to Checkers in this area which leaves little space for the pedestrian

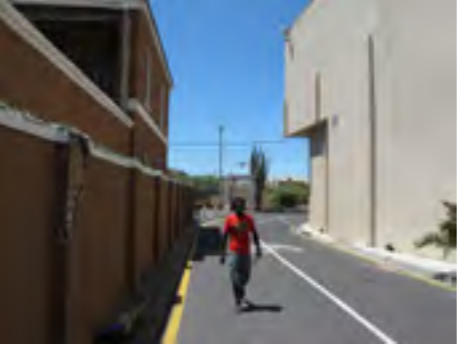
27. The subway entrance is clearly defined and in good clean condition

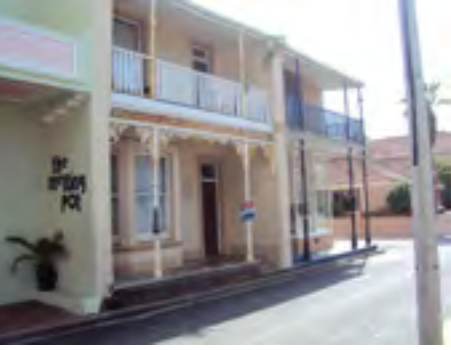
30. Church Street - there is a narrow sidewalk on one side of the road. Light posts and bins block the sidewalk.

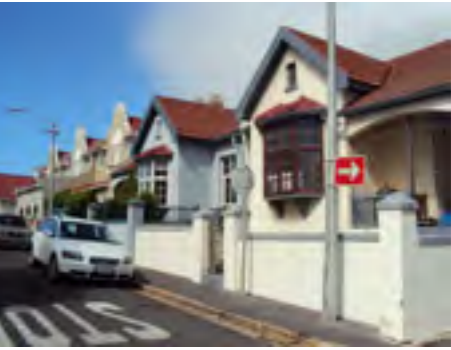
31. Hanson Street - the asphalt sidewalks with historical stone kerbs are in good condition.

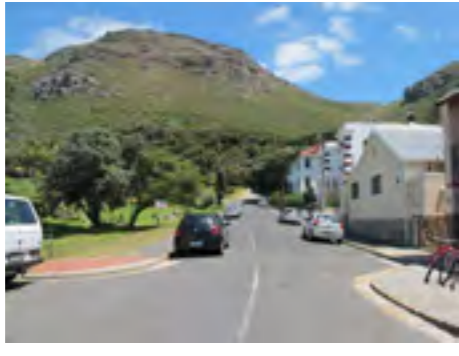
1. Entrance into Muizenberg Park is undefined.

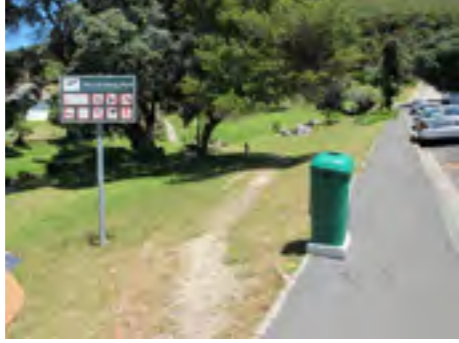
2. The signage does not reflect any character of the park or Muizenberg. The park is generally in a good condition and well maintained.

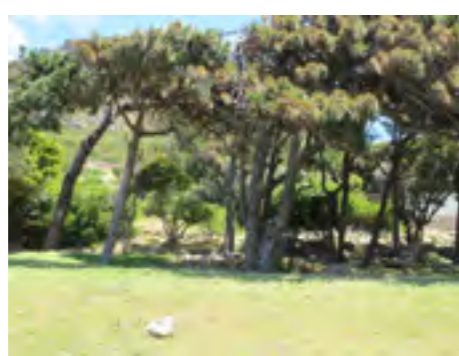
6. Upper end of the park is inhabited by vagrants and feels unsafe.

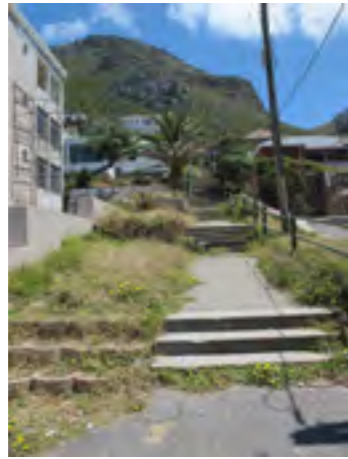
12. Informative signage is needed to indicate where the stairs lead to.

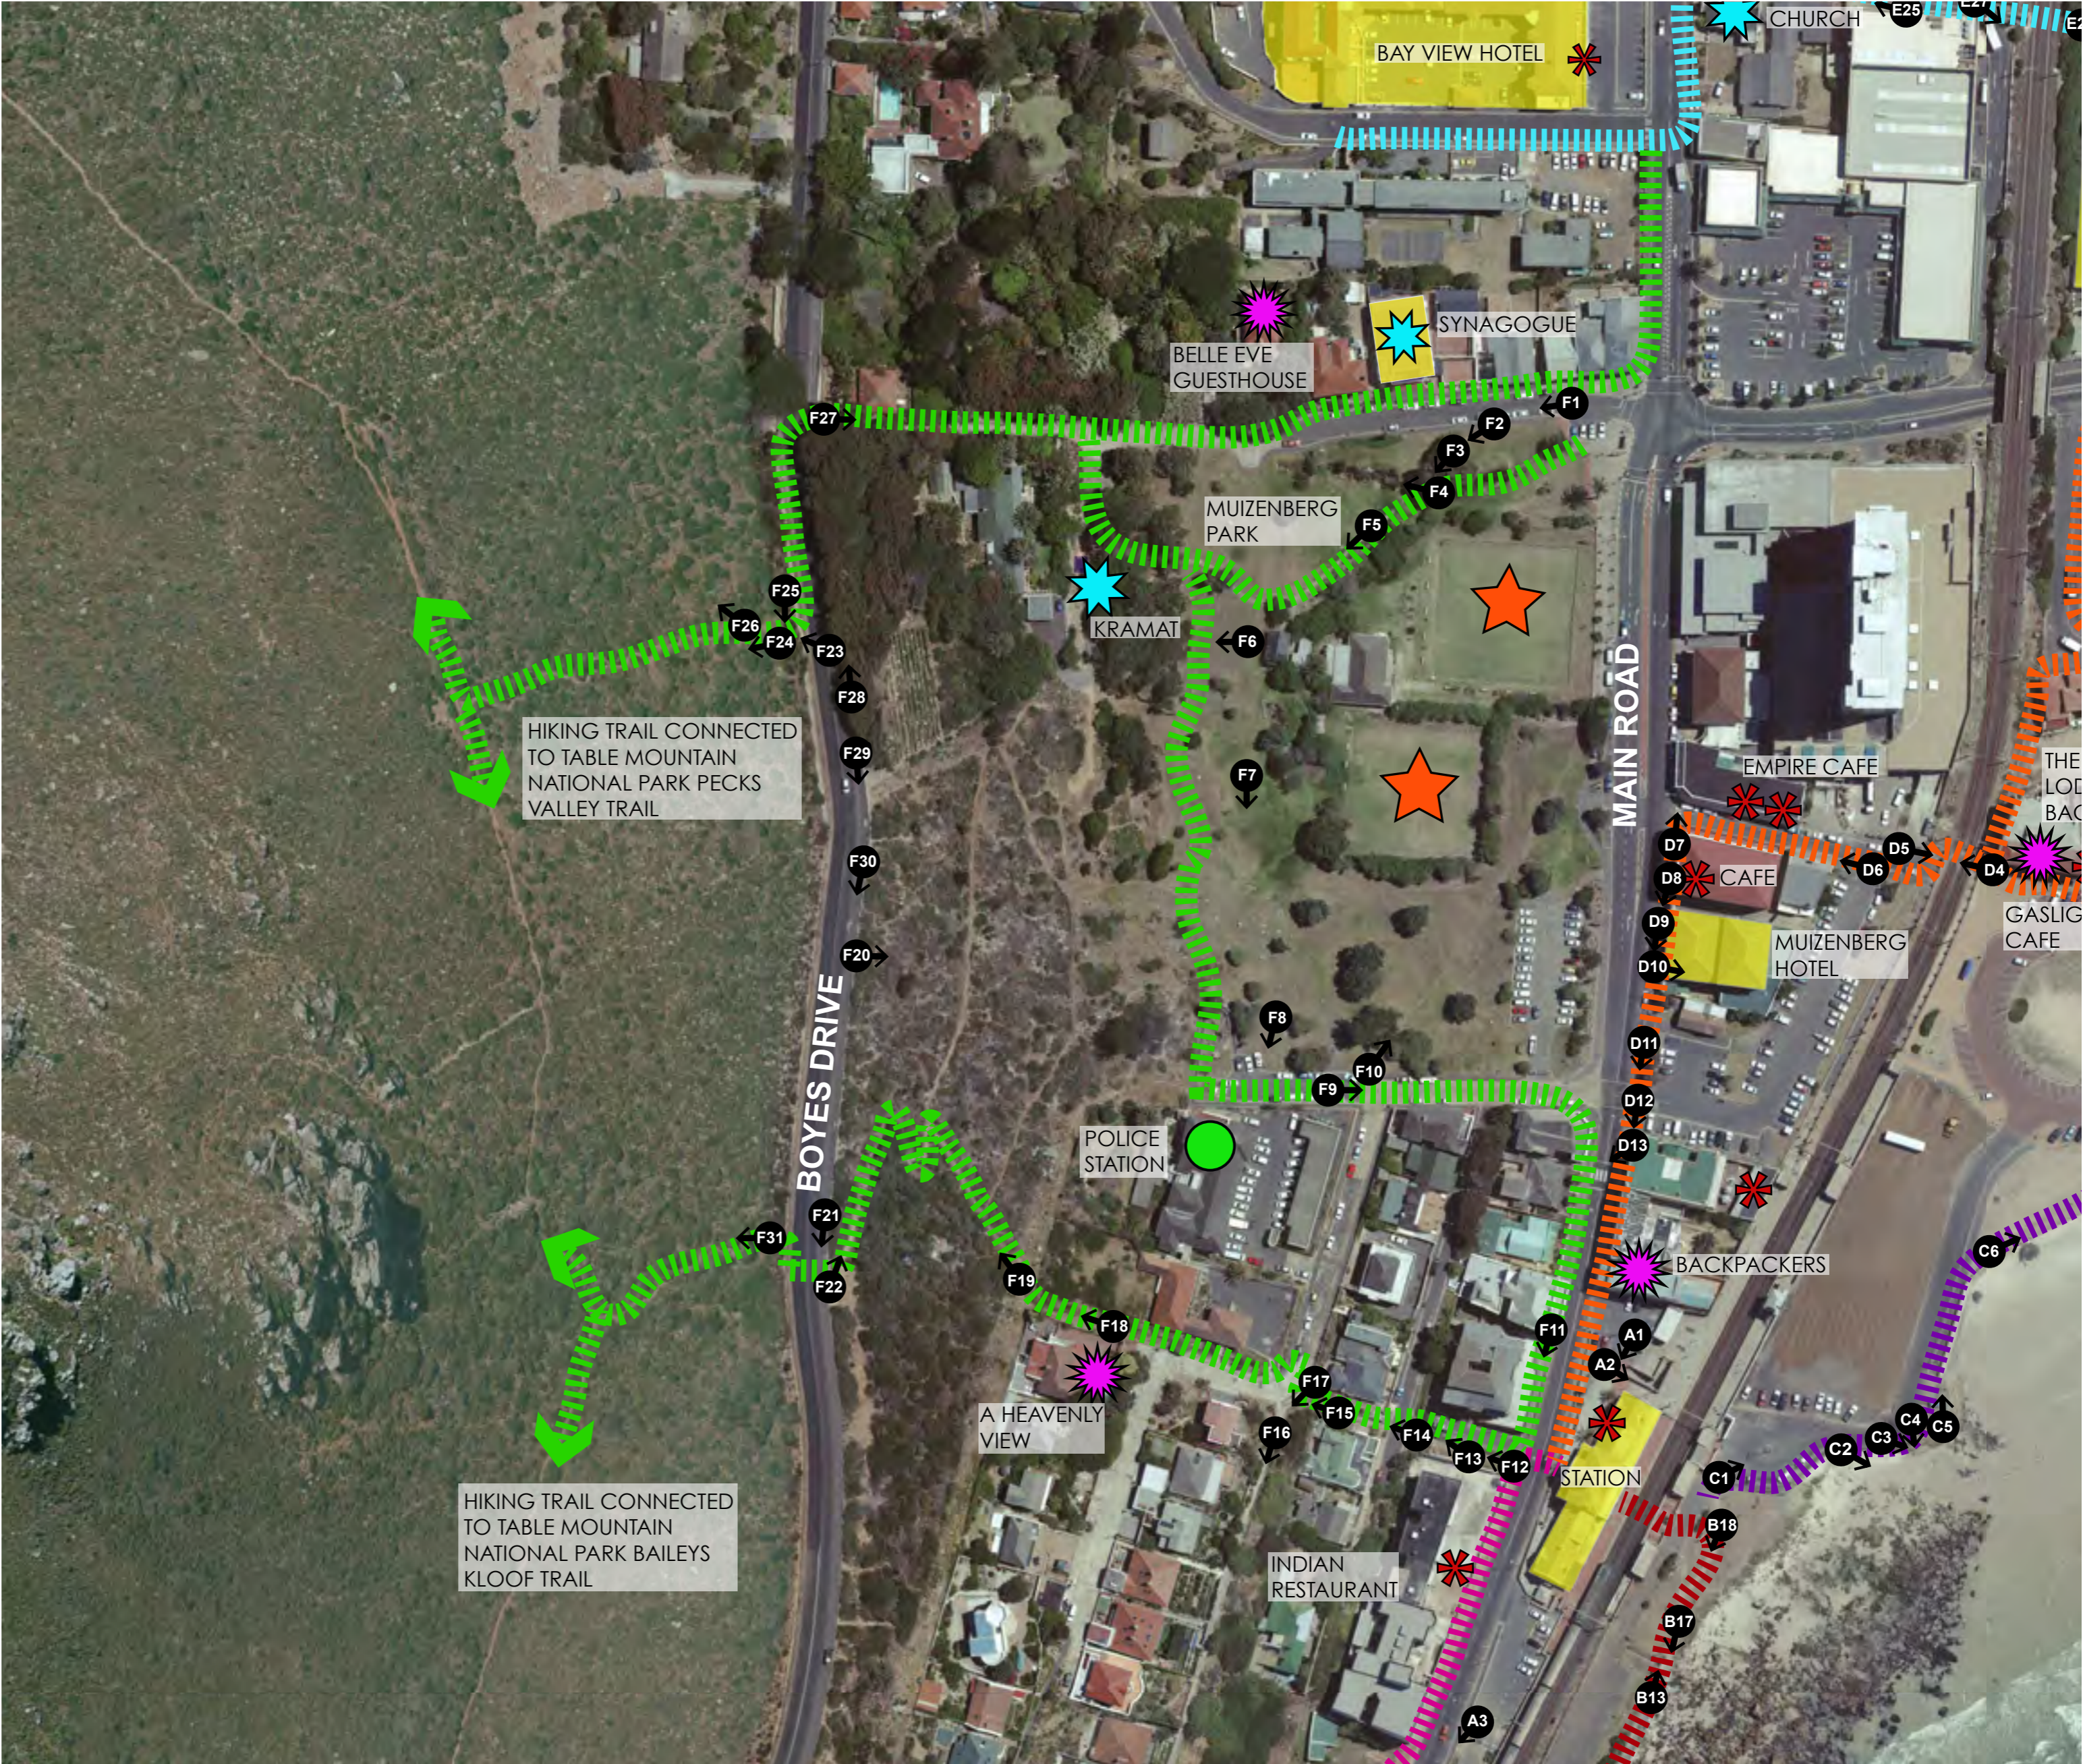
15. Concrete finish on top of brick paving is disintegrating on the stairway and in need of repair.

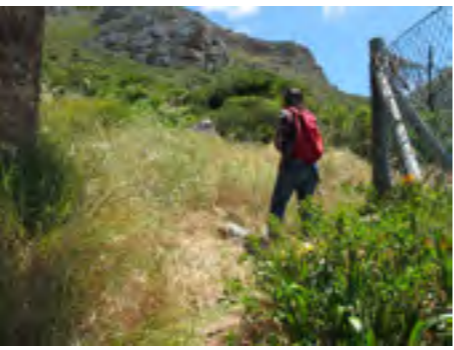
17. Footpath leading up to Boyes Drive is overgrown and not clearly demarcated. Informative signage is needed to indicate that there is access to the hiking trails further up.

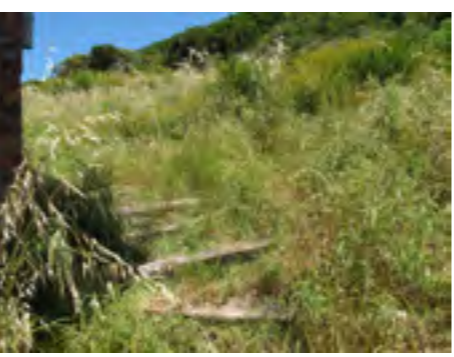
19. Railway sleepers need to be leveled and the footpath should be cleared and clearly demarcated.

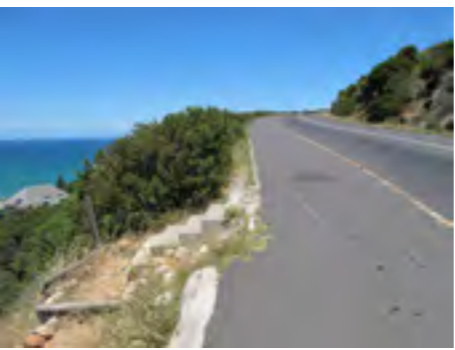
21. Informative signage is needed at this point to indicate routes and directions to pedestrians.

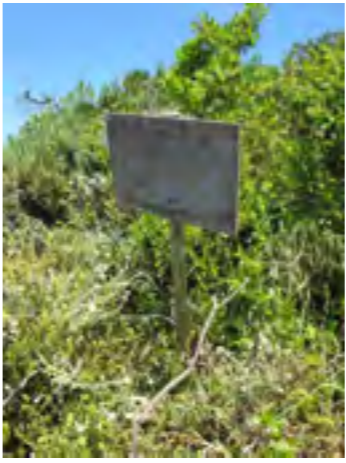
25. Old, blank signboard to be removed.

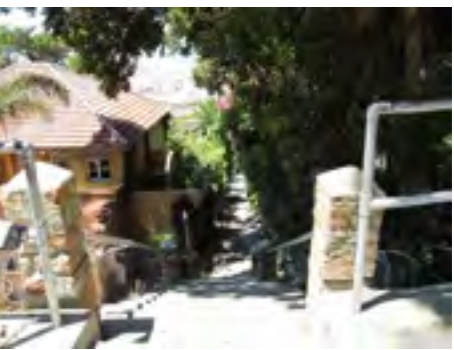
27. Stairway leading up to Boyes Drive. Informative signage is needed at this point to orientate pedestrians.

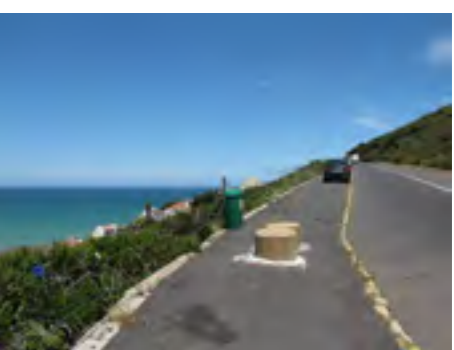
29. Exposed aggregate bollards placed at random along the sidewalk could be removed.
